505 University Avenue, Toronto- Site investigation report

Prepared by:	Donovan Pauly, MSc, CAHP, APTi (Architectural Materials Conservator)
Prepared for:	Sam Trigilia
Location:	505 University Avenue, Toronto, Ontario
Date of site visit:	September 16-25

Objective

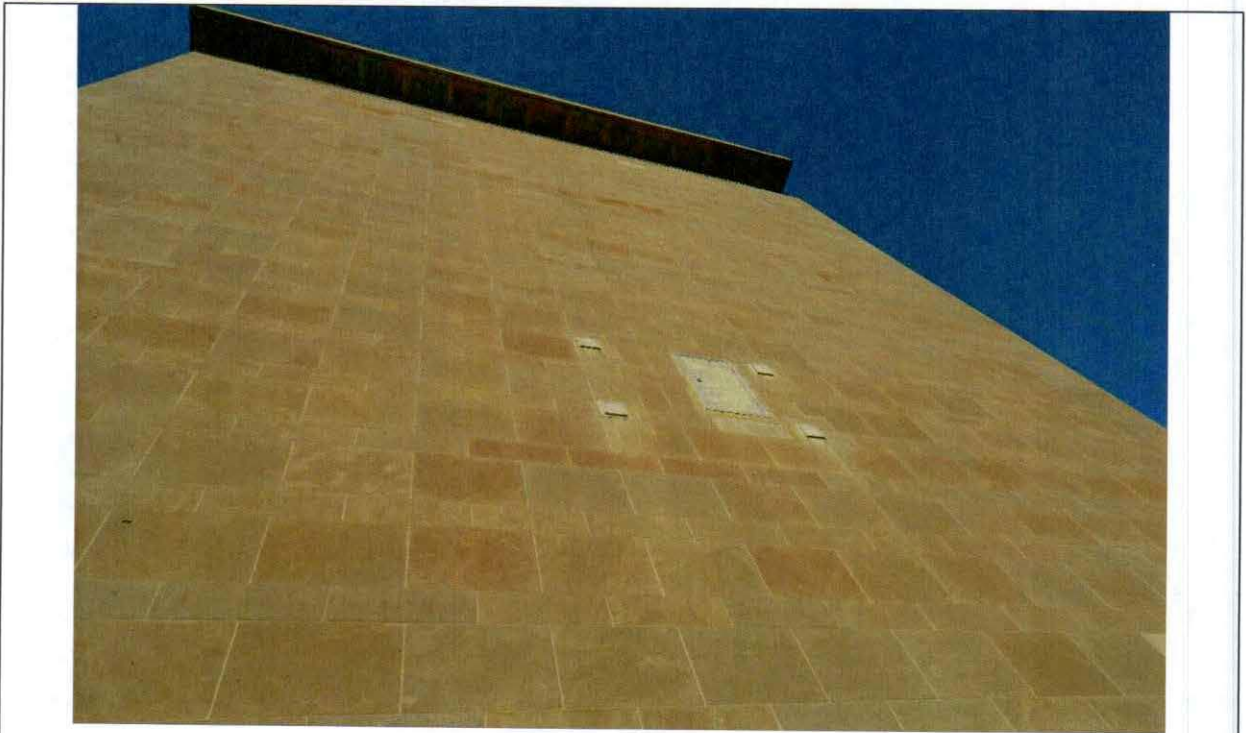
Figure 62 East elevation access door and old signage mounts.

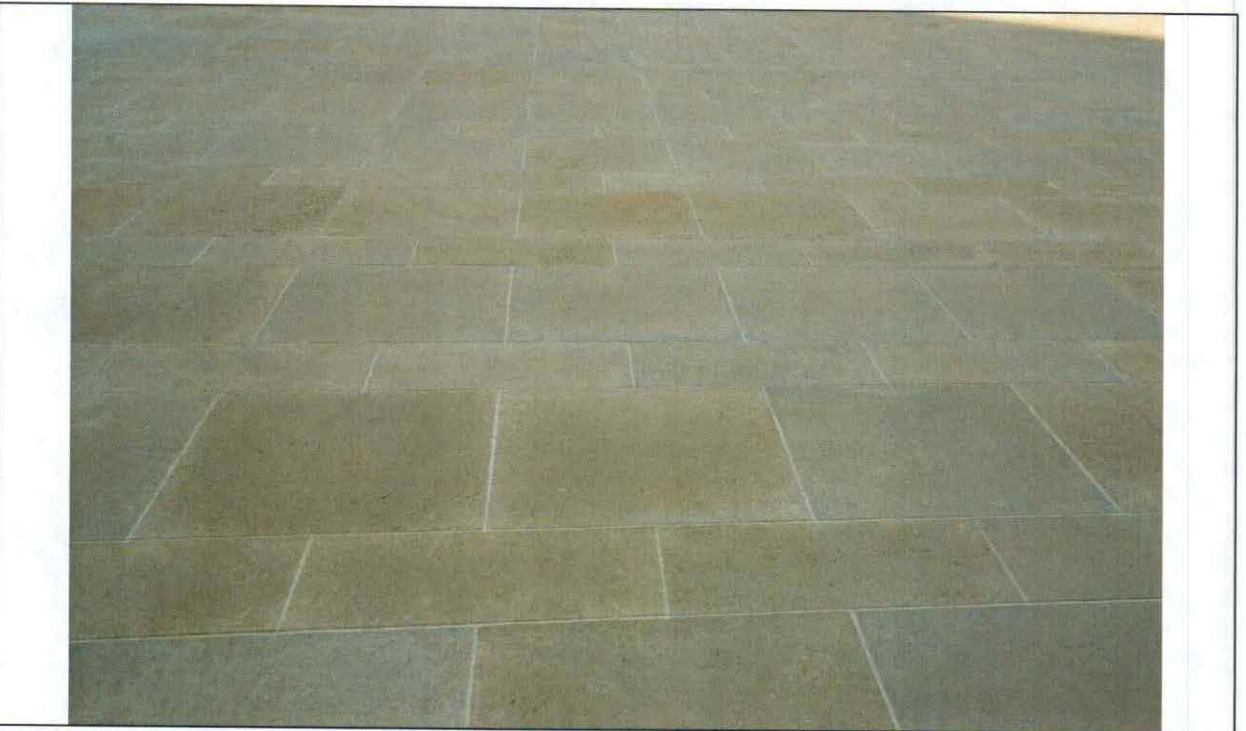
Figure 63 East elevation floors 7-10. The masonry is in good condition.

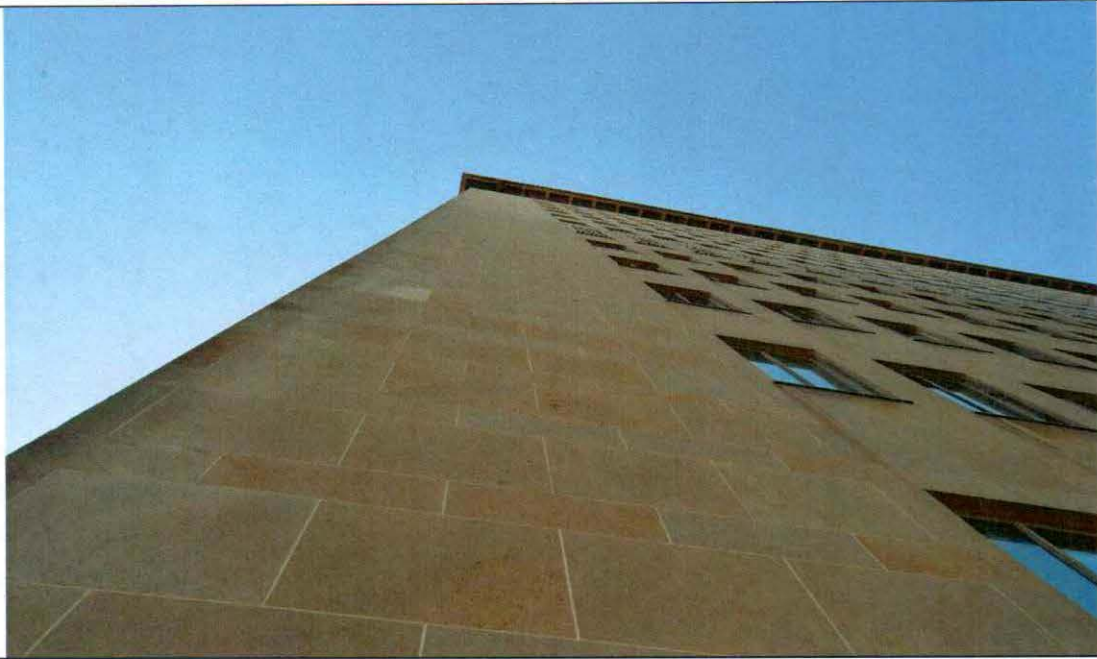
Figure 66 North elevation at east end floors 8-20. The masonry is in good condition.

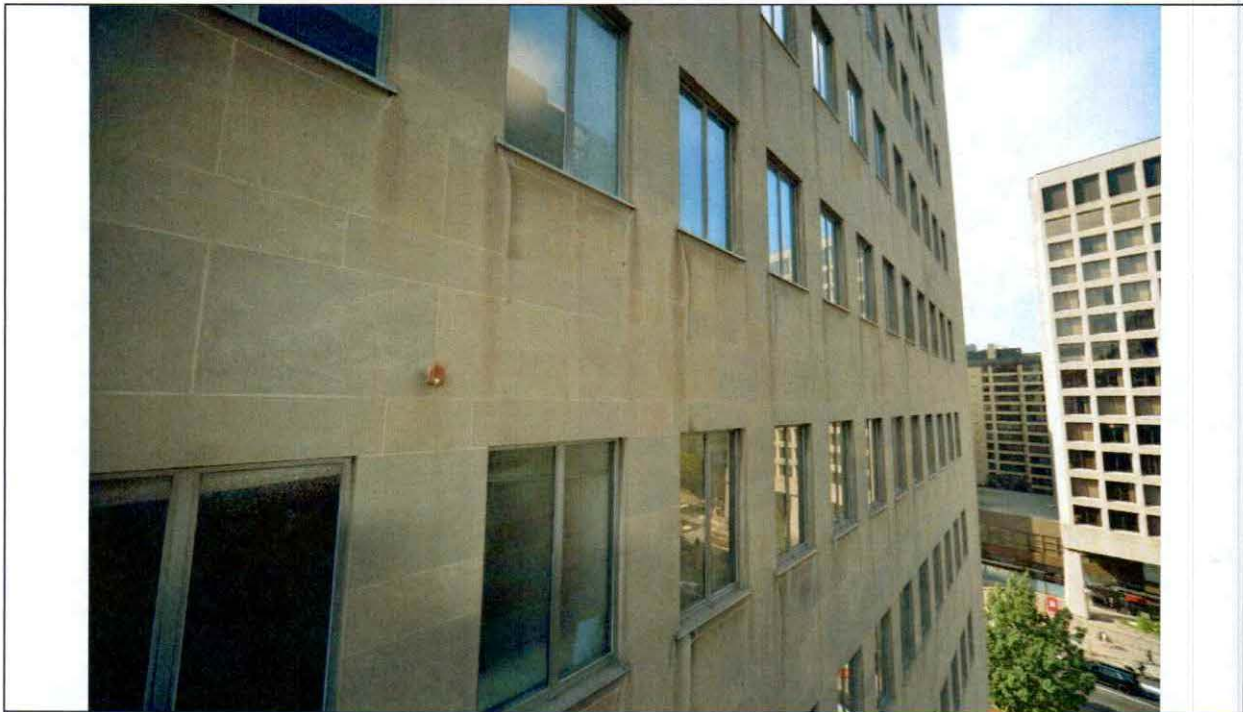
Figure 74 North elevation typical condition of masonry and windows at the 7th floor.

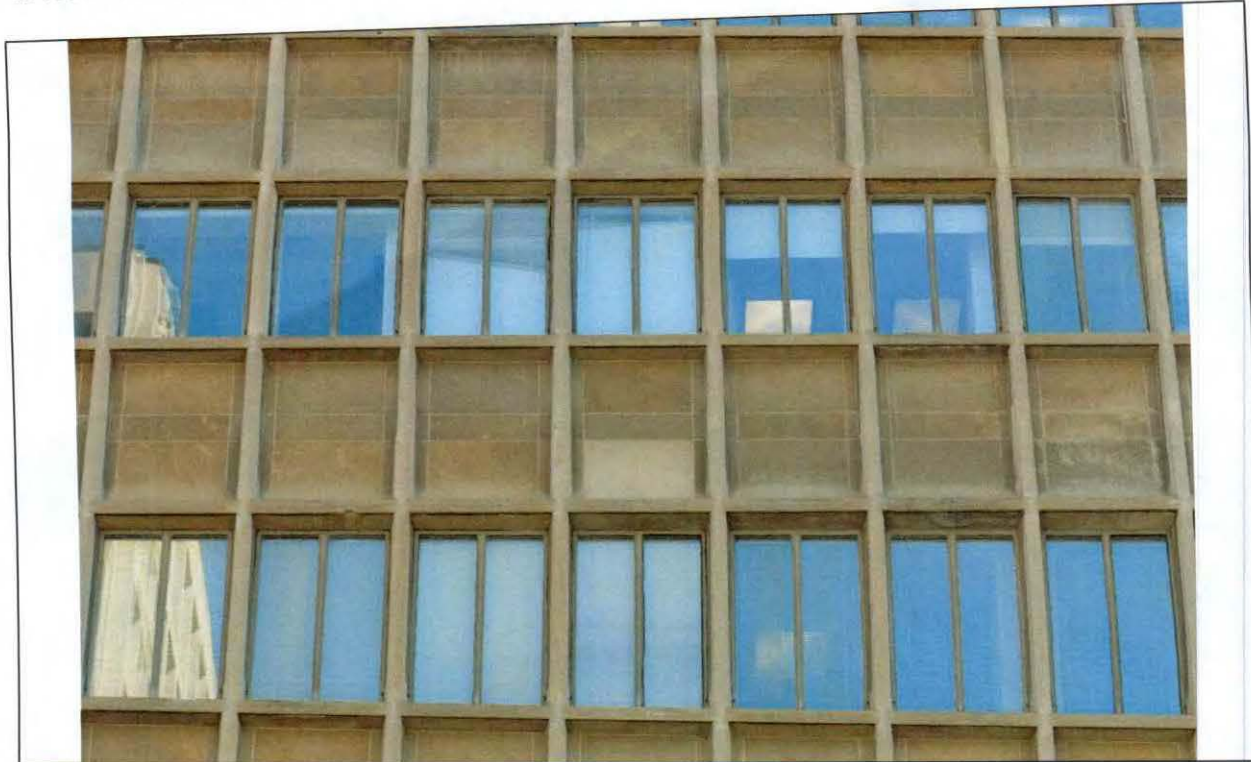
Figure 84 West elevation lost section of drip edge on lintel and typical sill/ lintel weathering erosion at the 4-5th floors.
