## 505 University Avenue, Toronto- Site investigation report

| Prepared by: | Donovan Pauly, MSc, CAHP, APTi (Architectural Materials Conservator) |
| Location: | 505 University Avenue, Toronto, Ontario |
| Date of site visit: | September 16-25 |

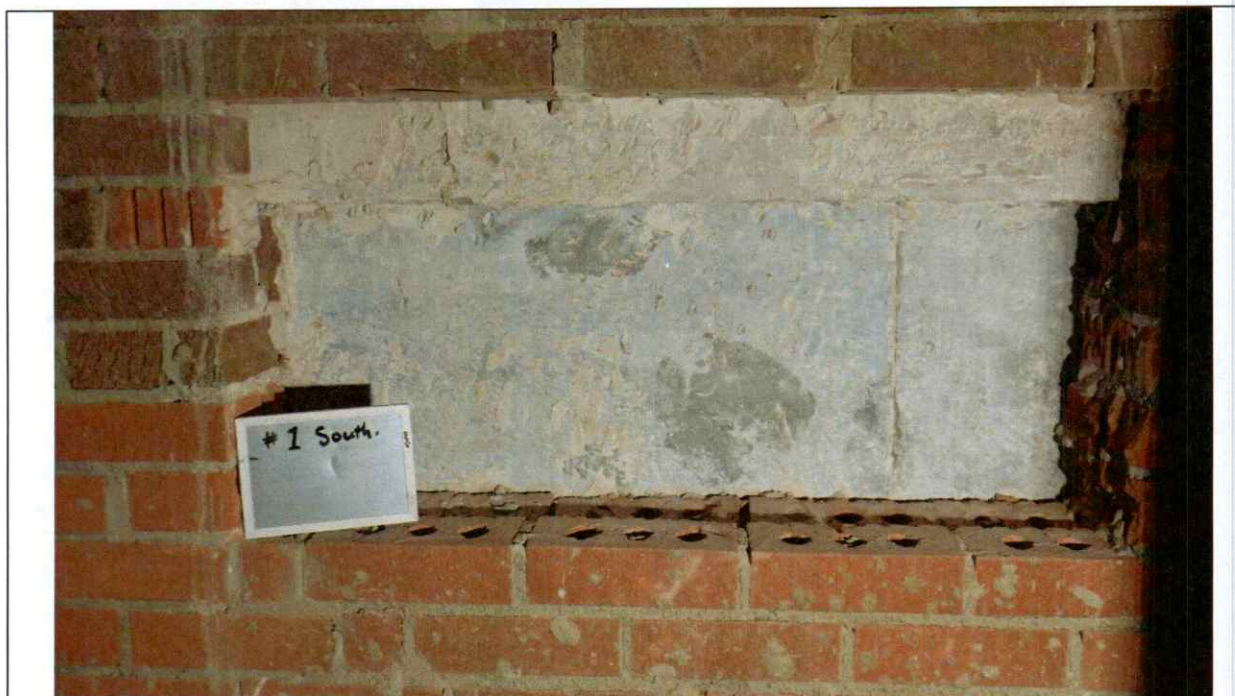
**Figure 10** Investigation opening #1 in vent shaft. 2 wythes brick masonry to back of stone.

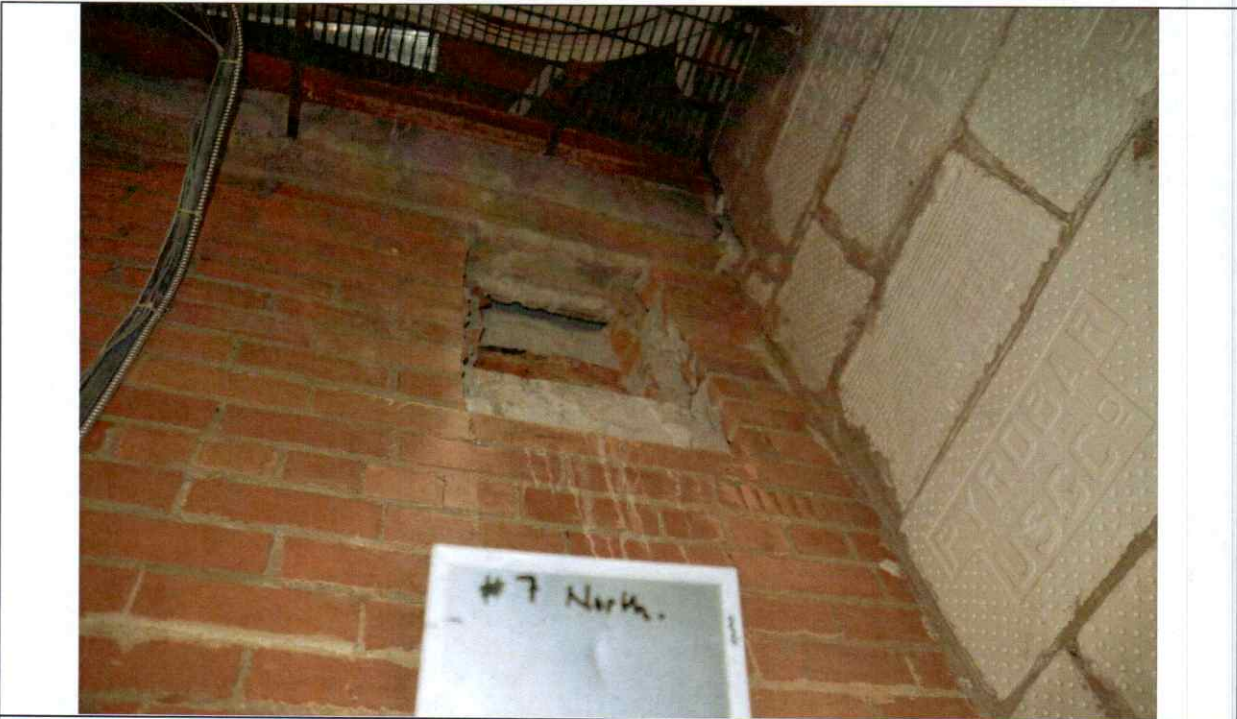
**Figure 22** Investigation opening #7 in vent shaft underside of the ring beam.

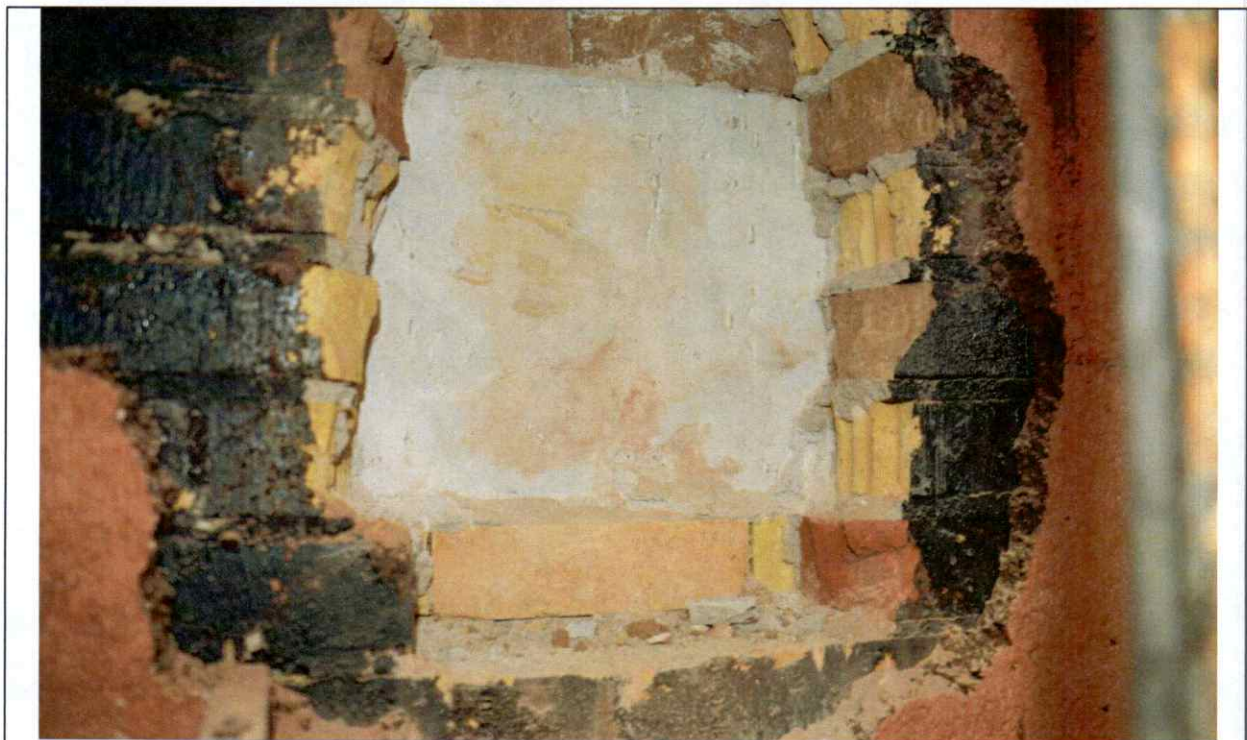
**Figure 37** Investigation opening #14 Detail. Corkboard and brick masonry were removed. Stone is block bonded into backup.

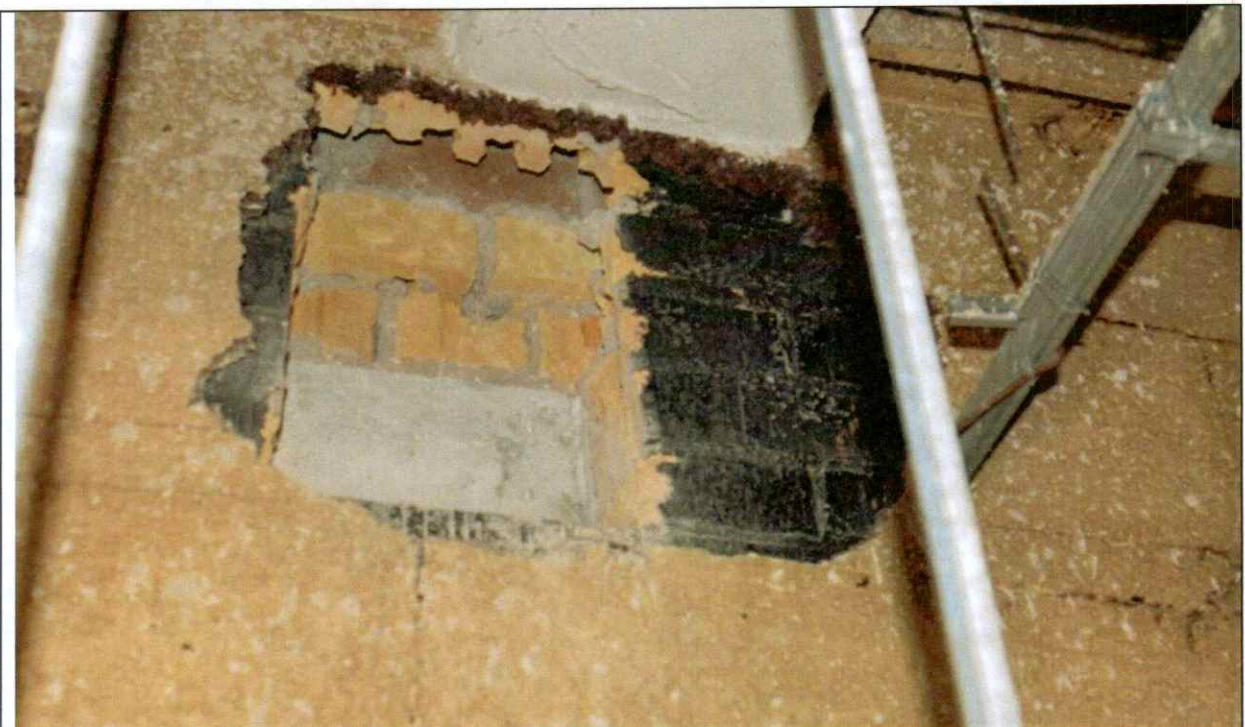
**Figure 45** Investigation opening #18 Detail. Corkboard and brick masonry were removed. Stone is block bonded into backup.

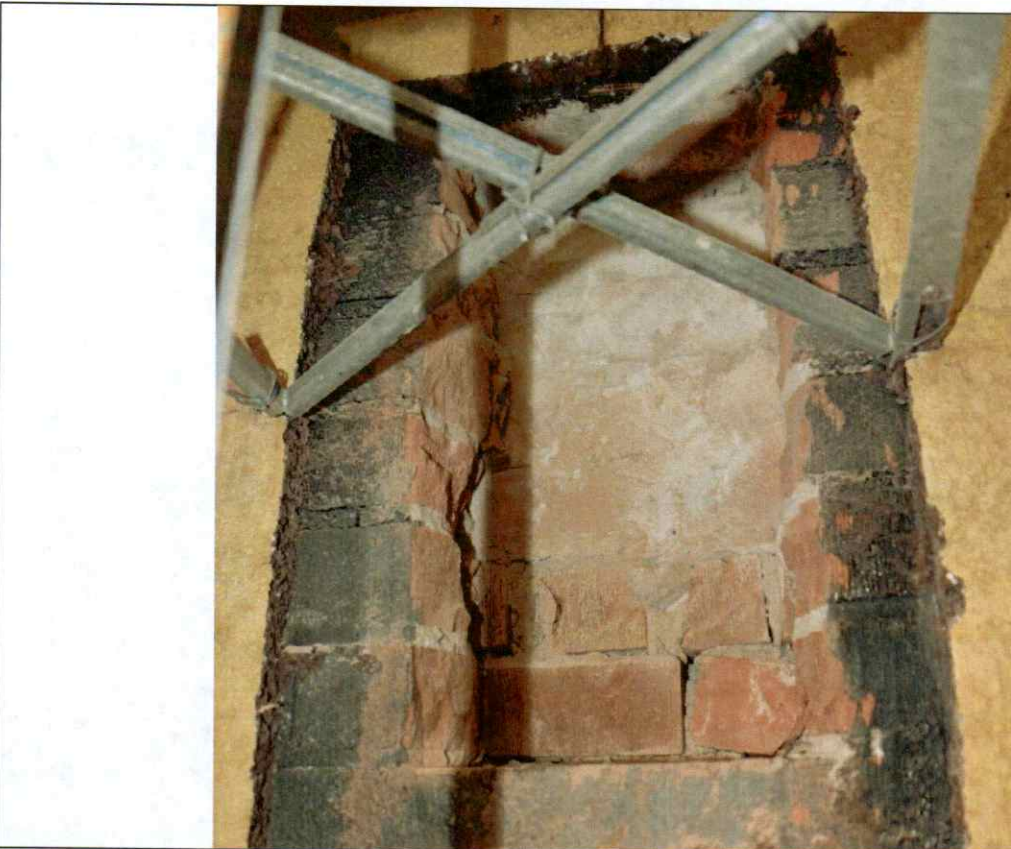
**Figure 47** Investigation opening #19 Detail. Corkboard and brick masonry were removed. Stone is block bonded into backup.

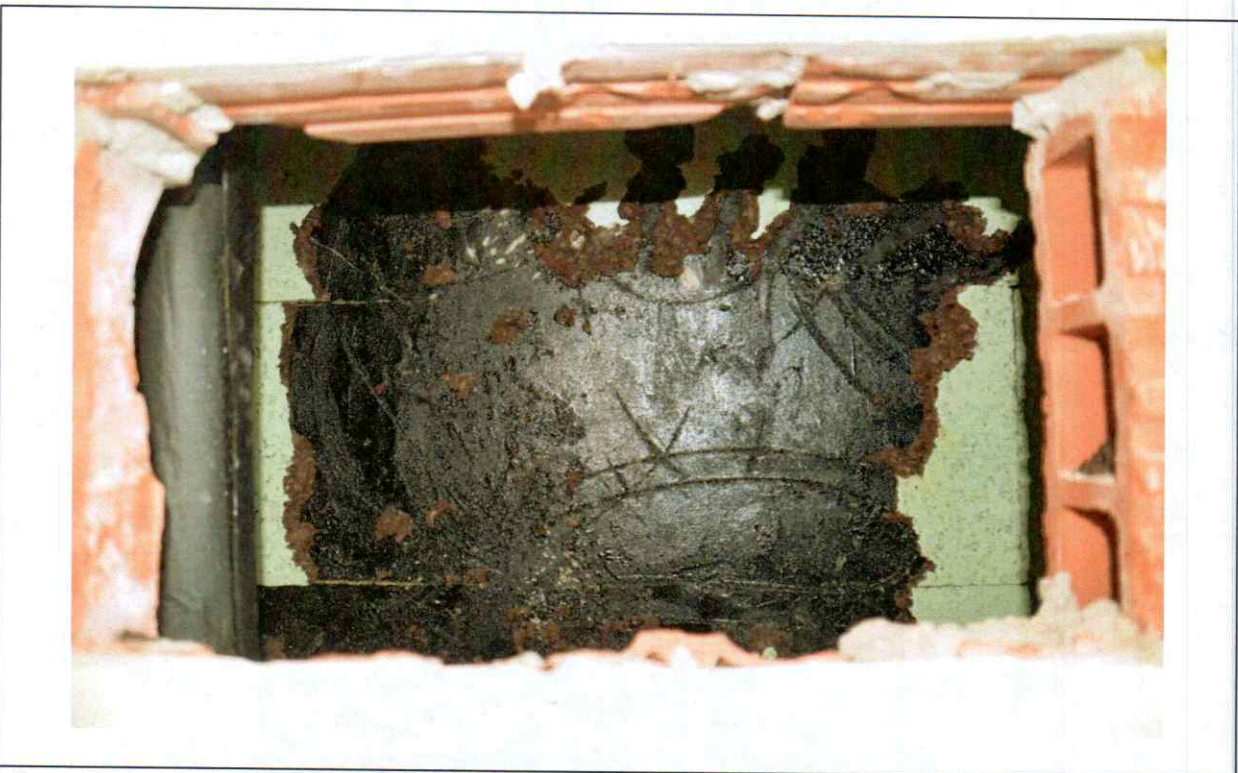
**Figure 51** Investigation opening #21 Detail. The corkboard was removed back of the stone was parged and bitumen paint coated.

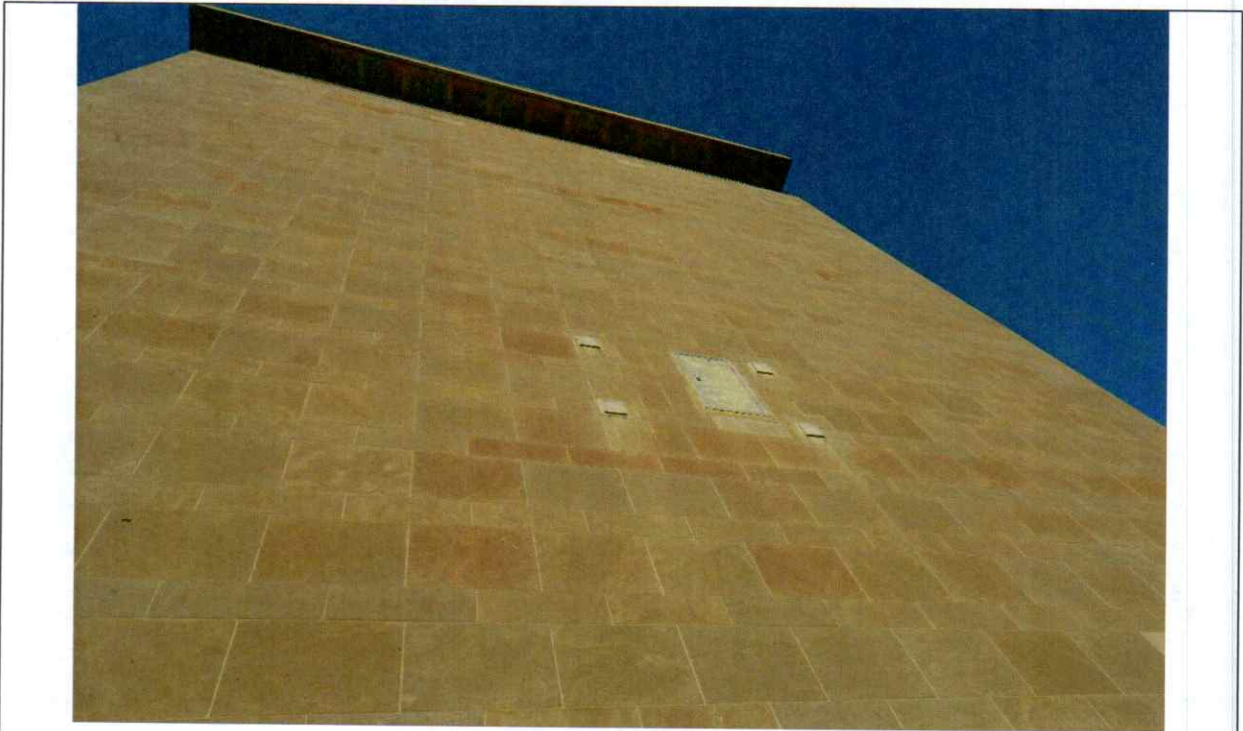
**Figure 62** East elevation access door and old signage mounts.

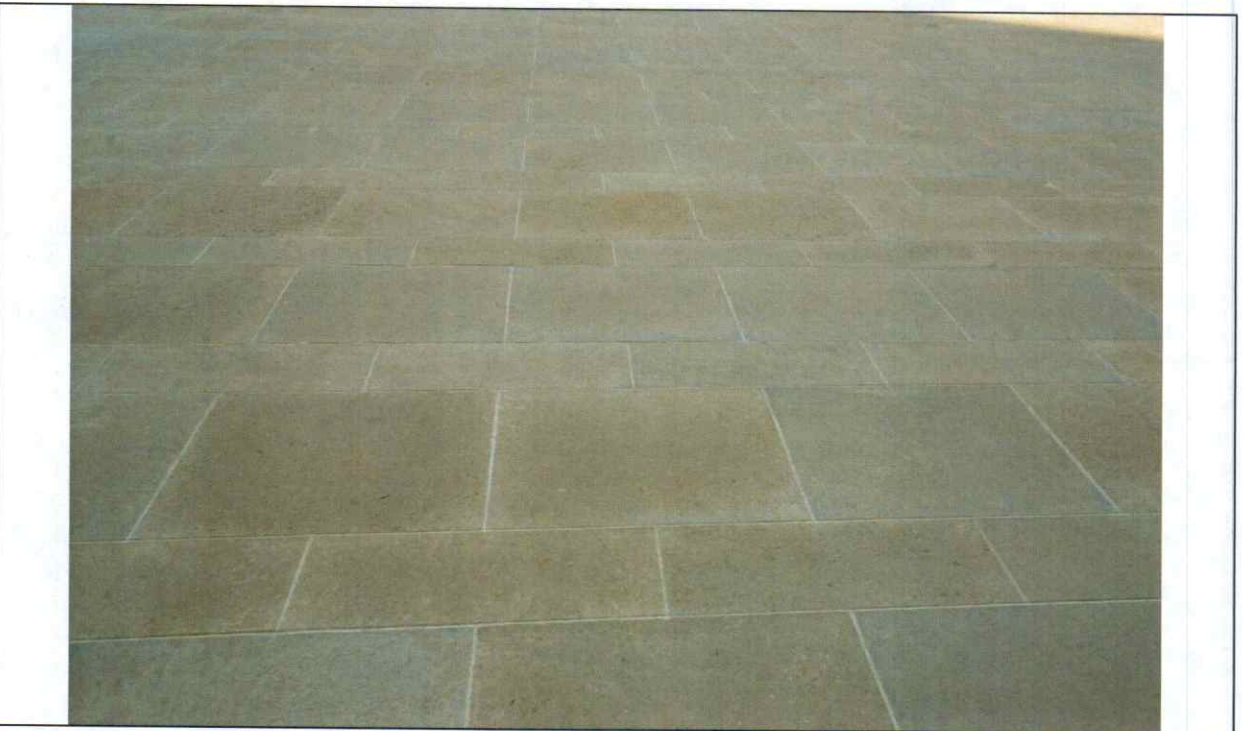
**Figure 63** East elevation floors 7-10. The masonry is in good condition.

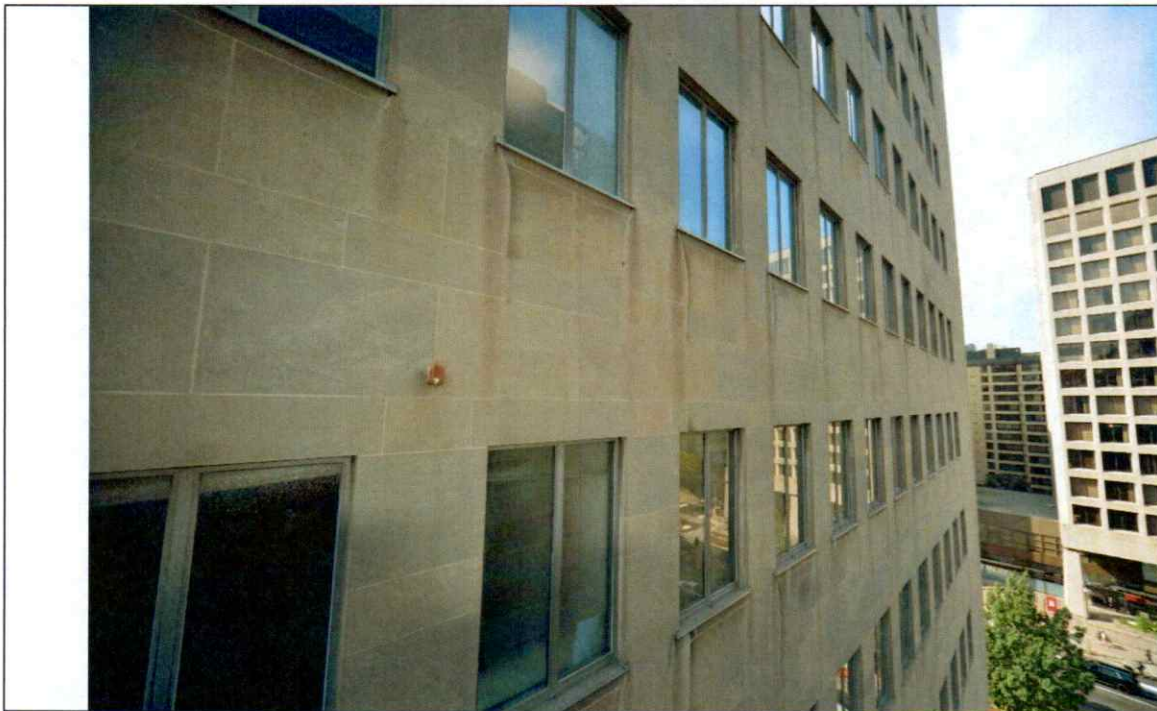
**Figure 74** North elevation typical condition of masonry and windows at the 7<sup>th</sup> floor.

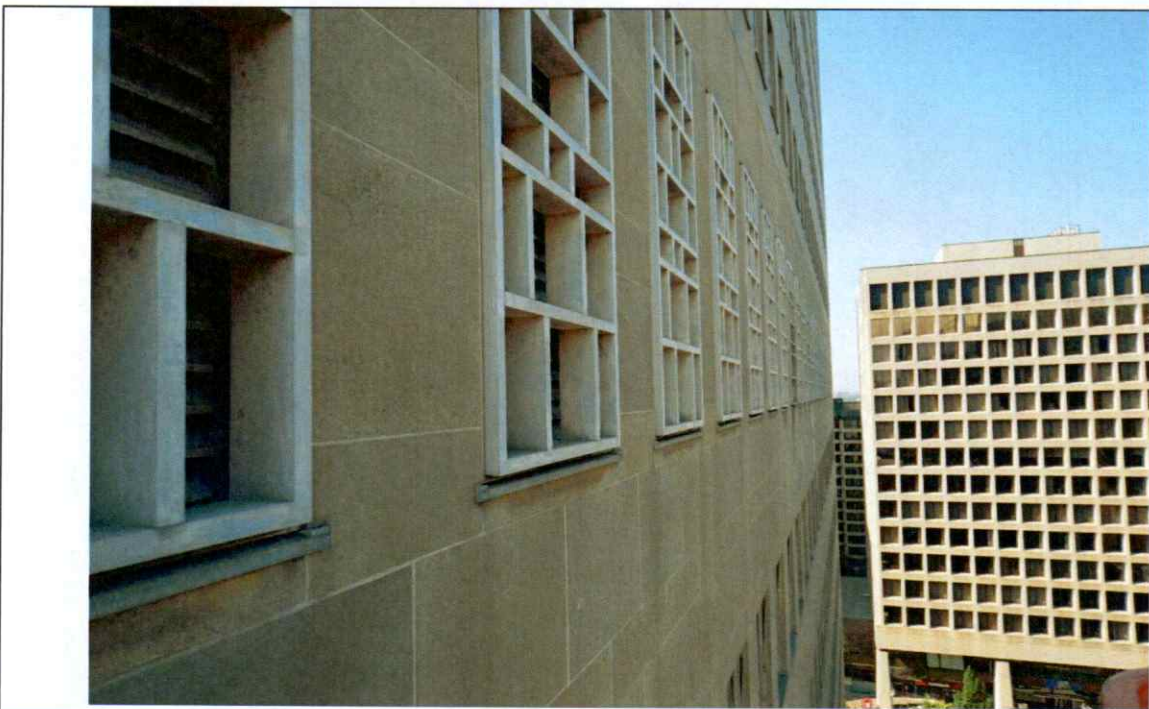
**Figure 75** North elevation vent screens at the 13<sup>th</sup> floor. The masonry is generally in good condition.

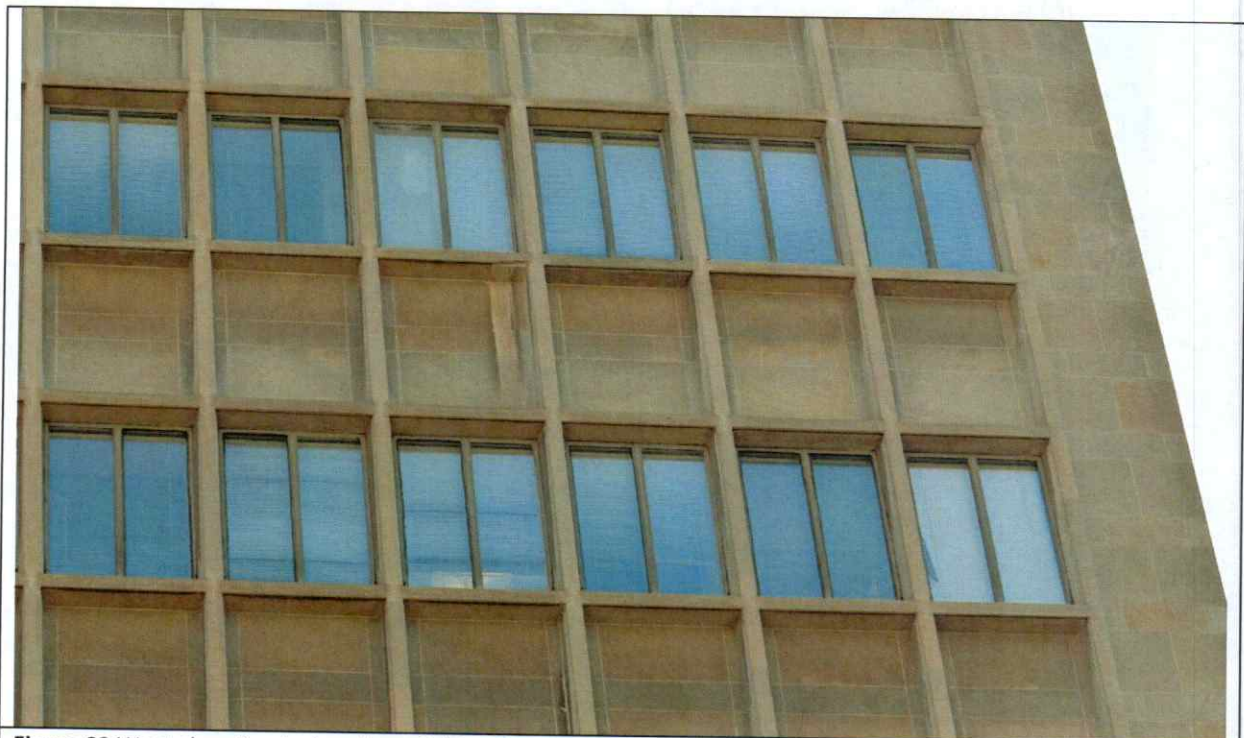
**Figure 83** West elevation lost section of drip edge on the sill at the 9<sup>th</sup> floor.

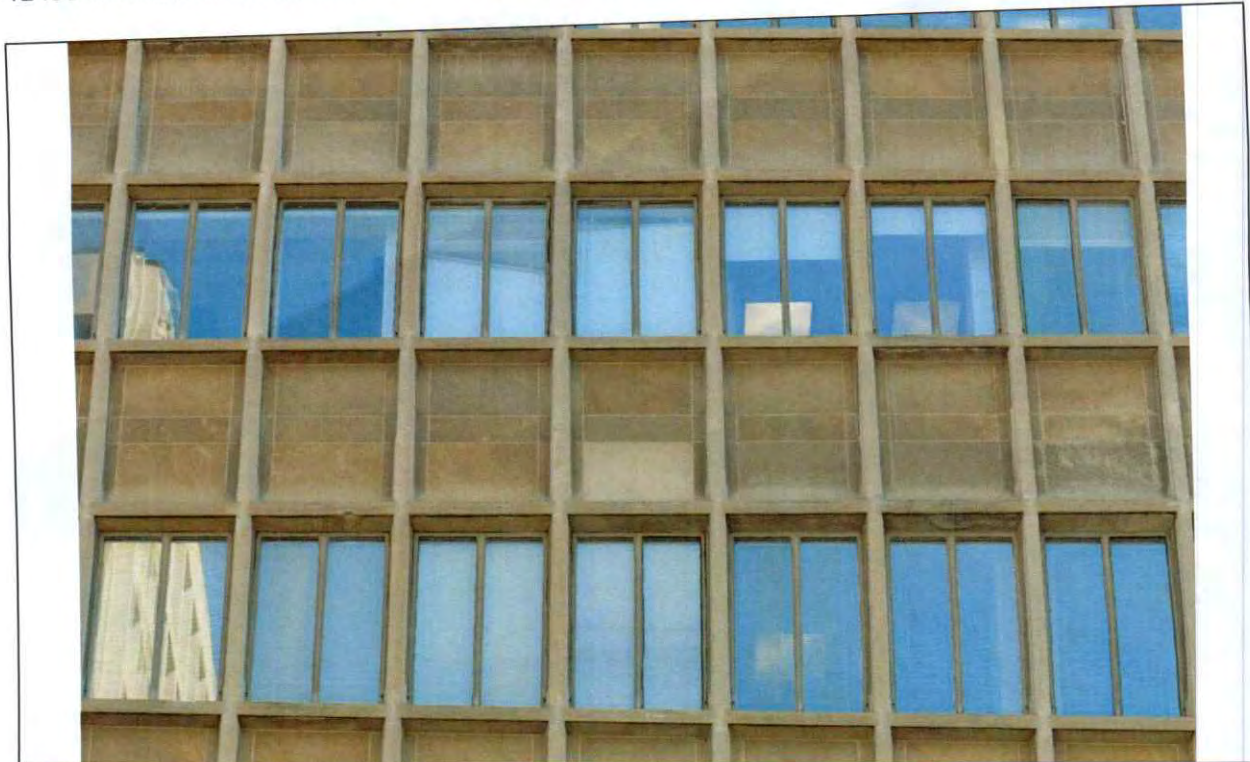
**Figure 84** West elevation lost section of drip edge on lintel and typical sill/ lintel weathering erosion at the 4-5<sup>th</sup> floors.
