GERMAN MILLS CREEK GEOMORPHIC SYSTEMS MASTER PLAN MONITORING REPORT APPENDIX E

GERMAN MILLS CREEK GEOMORPHIC SYSTEMS MASTER PLAN SHORT-TERM EROSION MONITORING REPORT

GERMAN MILLS CREEK GEOMORPHIC SYSTEMS MASTER PLAN

SHORT TERM EROSION MONITORING REPORT

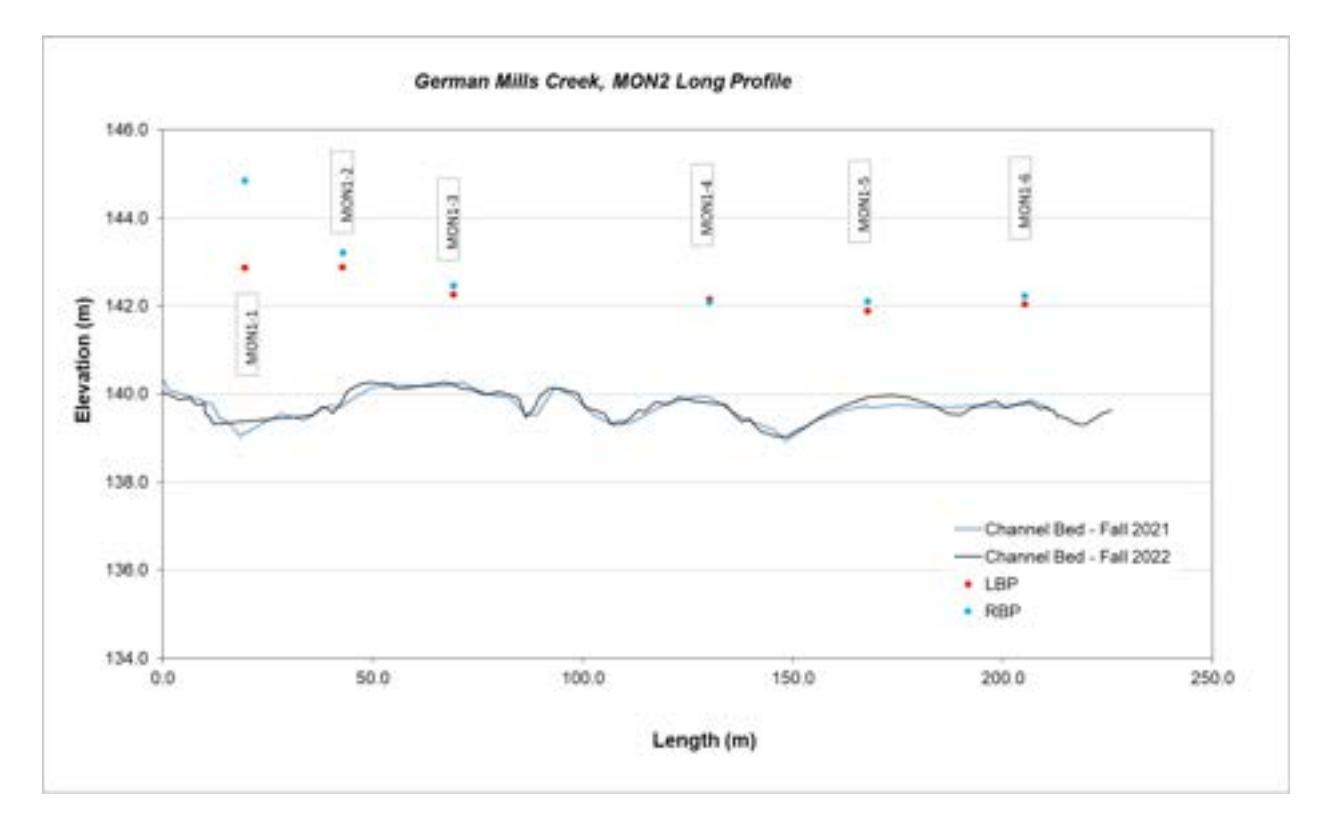
FIGURE B Overlay of Year 1 and Year 2 Longitudinal Profile for MON2

- In MON2, riffle crests generally did not migrate between the monitoring years. Two riffle crests increased in height by 2 and 22 cm, one decreased in height by 10 cm, and one remained static. The uneven riprap material lining parts of the bed could introduce local variation in the survey results of up to approximately 20 cm. so the slight variation in riffle elevation is not considered meaningful. The pool nearest the pedestrian crossing could not be surveyed due to excessive water depth so this pool cannot be compared between years. No downstream migration was observed within the other pools in MON2, and there was little to no infilling. The lack of bedform development is attributed to stabilization by riprap.

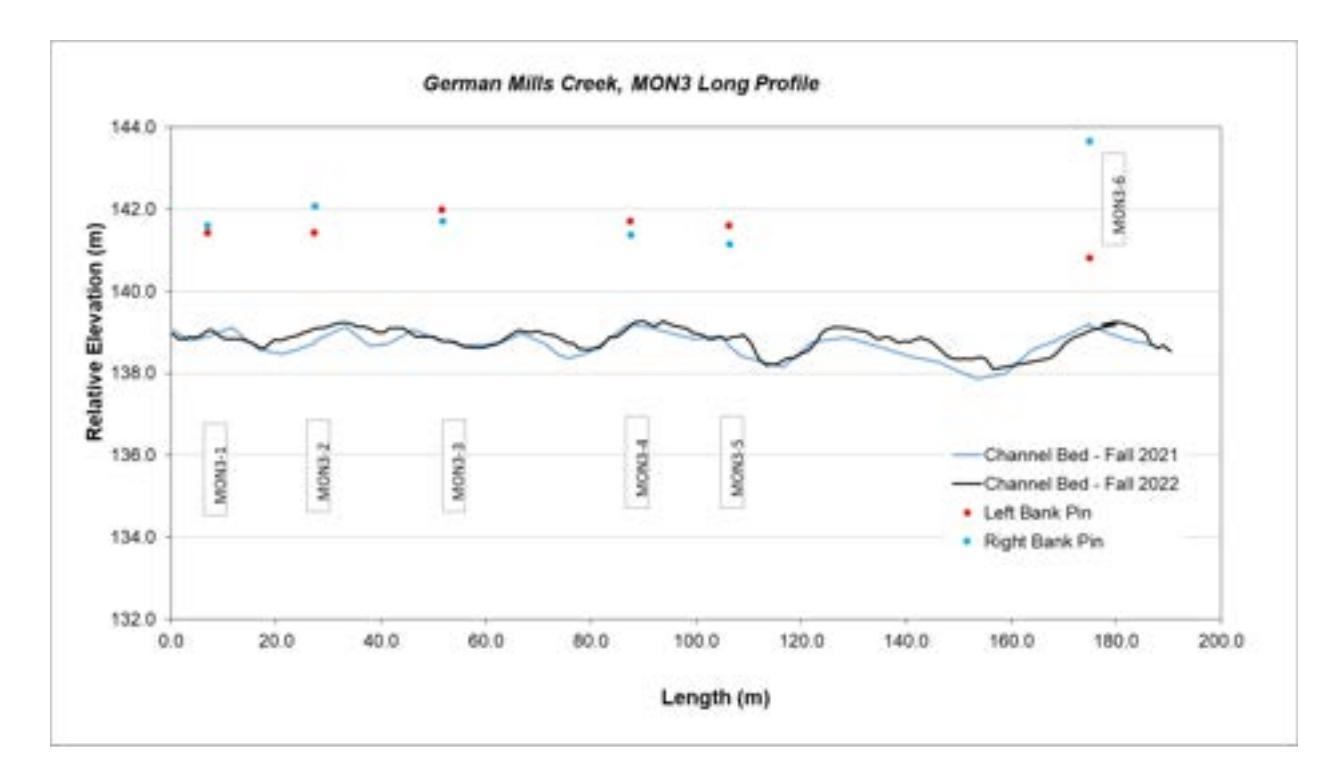
FIGURE C Overlay of Year 1 and Year 2 Longitudinal Profile for MON3

- MON3: This reach has a meandering planform, erodible sandy bank and an over-widened channel. There is no obvious pattern in the changes in bankfull width; three sections narrowed slightly, two widened, and one remained the same. However, channel depth decreased in five of six cross-sections resulting in a corresponding decrease in channel cross-sectional area. MON3-1 underwent the most change in cross-sectional profile due to channel migration toward the south bank nearest the pedestrian path; as observed in the repeat photos (Appendix B2, Photograph 2), the south bank receded by 2.3 m (large value due to local change in location of tree root ball; not representative of south bank as a whole), and a new tree fell between 2021 and 2022; however, this channel migration occurred without a significant change in bankfull cross-sectional area. Bank migration was generally in phase with the planform, with erosion occurring on the outside of meanders (for instance, migration to the south bank at MON3-1, MON3-3, and MON3-5, and to the north bank at MON3-6).

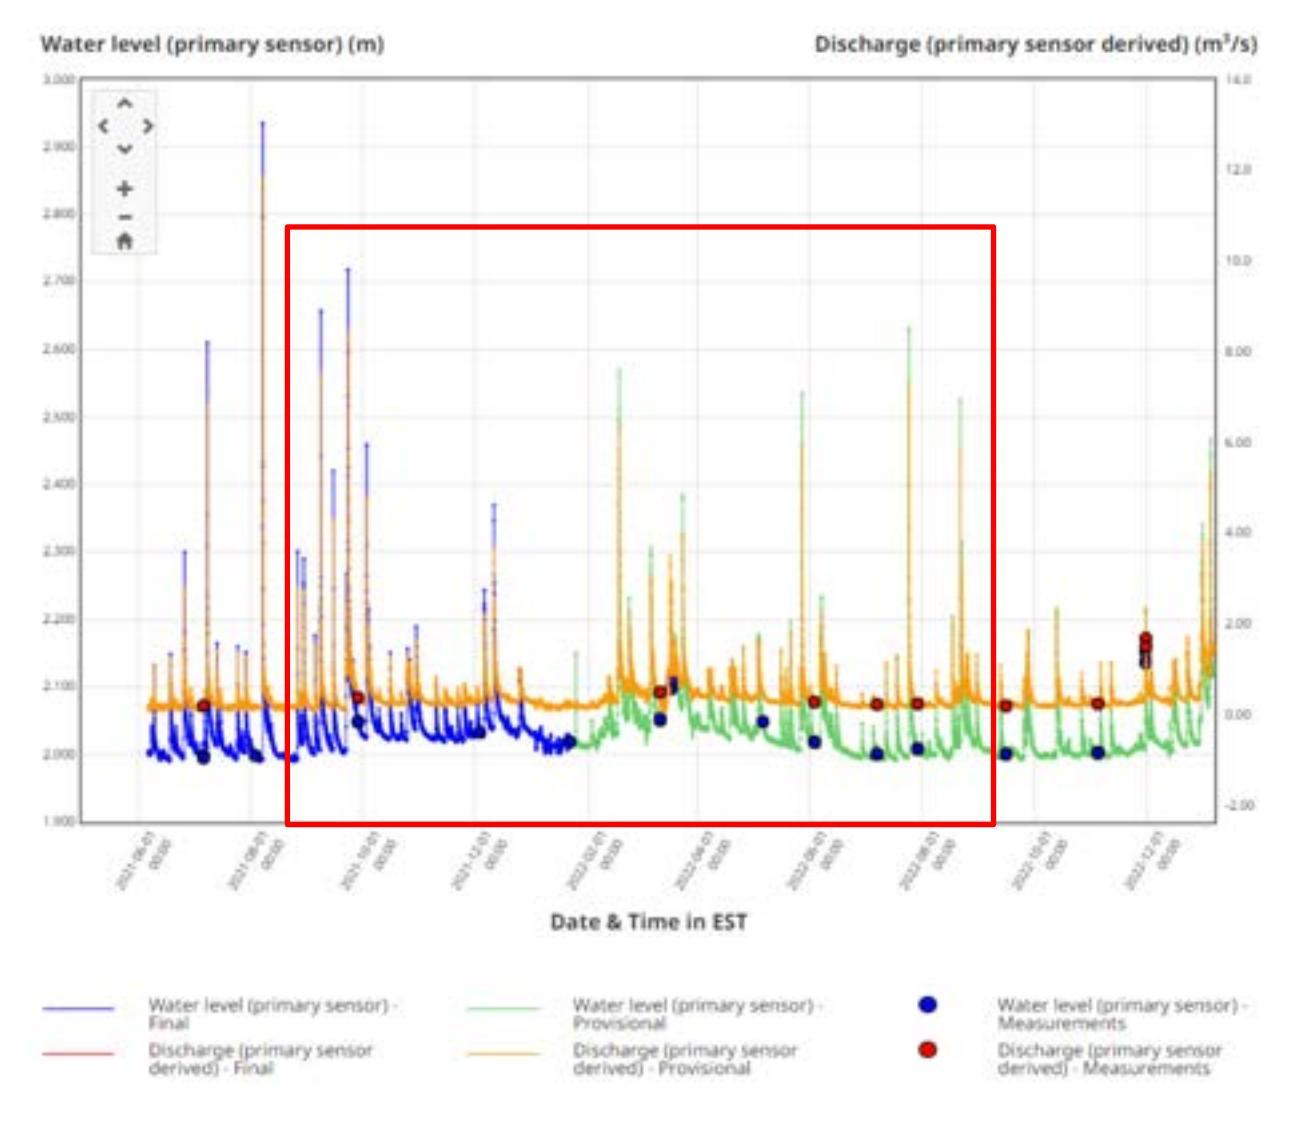
FIGURE G 2021-2022 Flow Rates, Don River East Branch near Thornhill (Government of Canada 2022)

The surveys were completed during summer and early fall low flow conditions, and the morphological adjustments captured in the data are a response to peak storm flows in the range of 4 to 8.5 m³/s, which occurred between monitoring years.

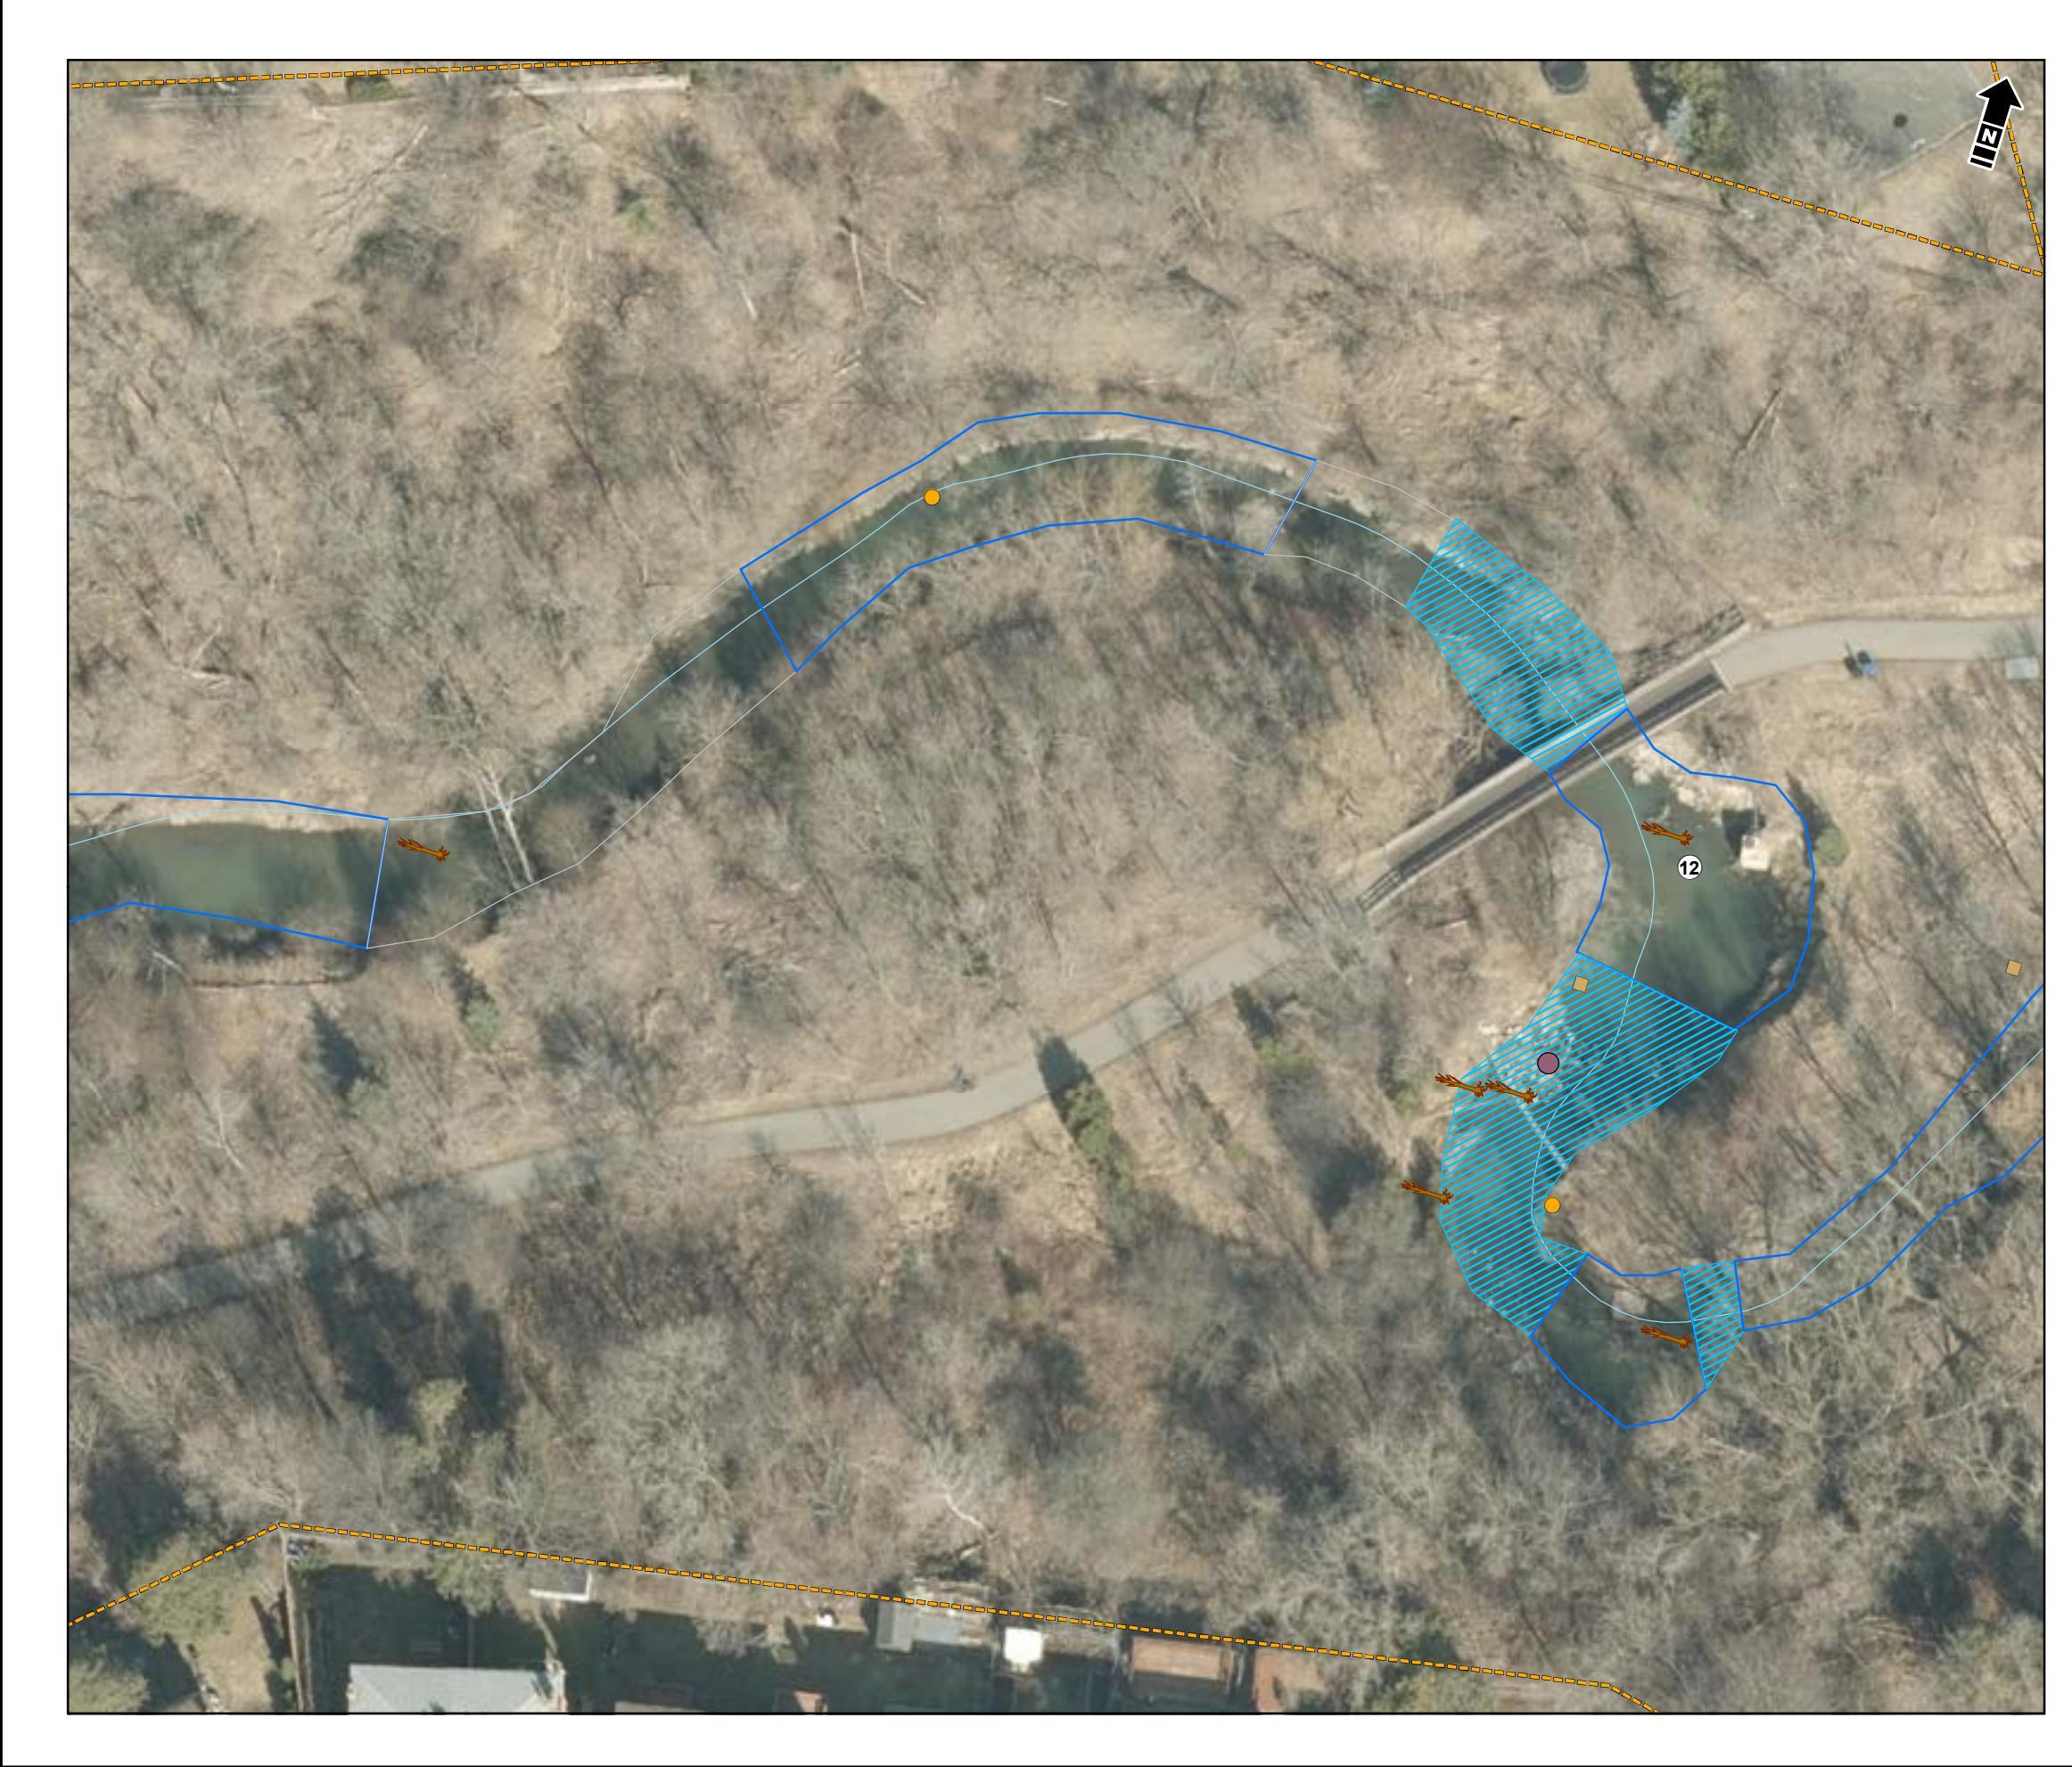
German Mills Creek GSMP C	ritical Area
Watercourse Eield Note	
Channel Units	
C3 Pool	
C Run	
Habitat Element Bar	
Boulder/Boulder Cluster	
Woody Debris	
Notes: 12. Pool with a wetted depth of over 1m. Ba	nks eroded. Sandy substrate.
Stoolog A	
Sieeles A	
5	
4

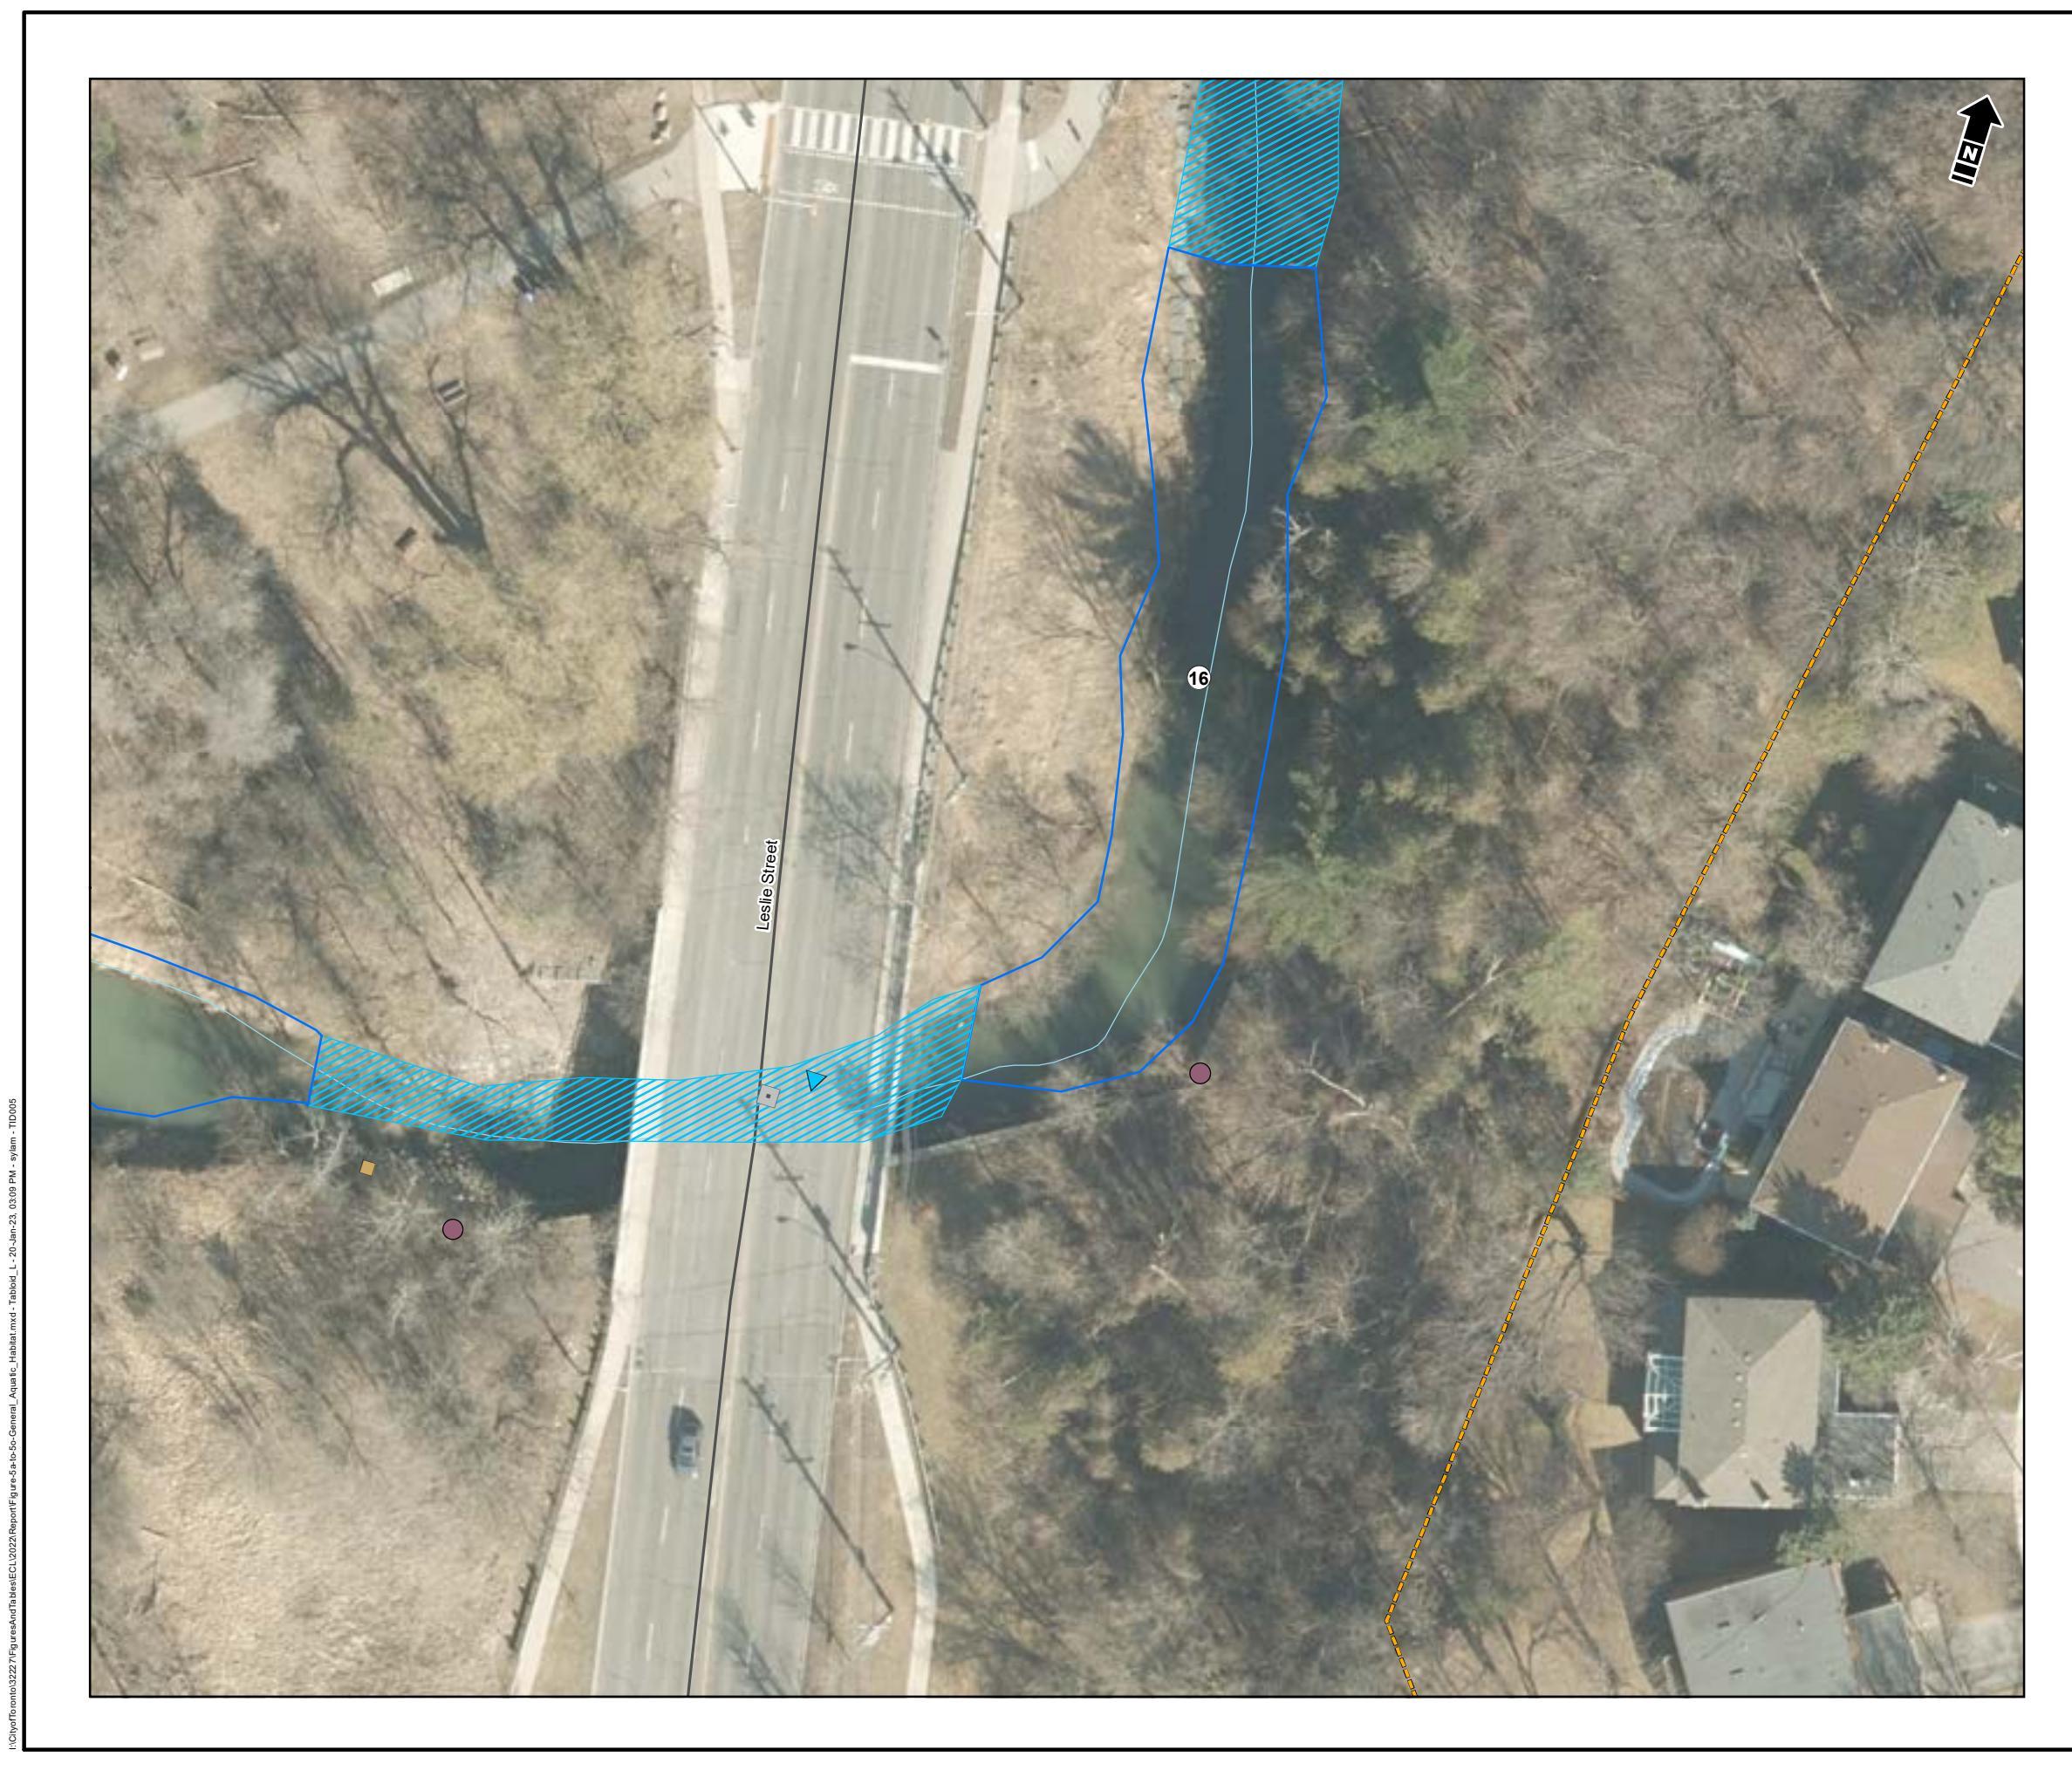
Notes: 16. Pool with a wetted width of 8.80m and wetted depth of 48 cm. Banks with overhanging vegetation and a pedestrian path on the left bank. Sandy gravel substrate.

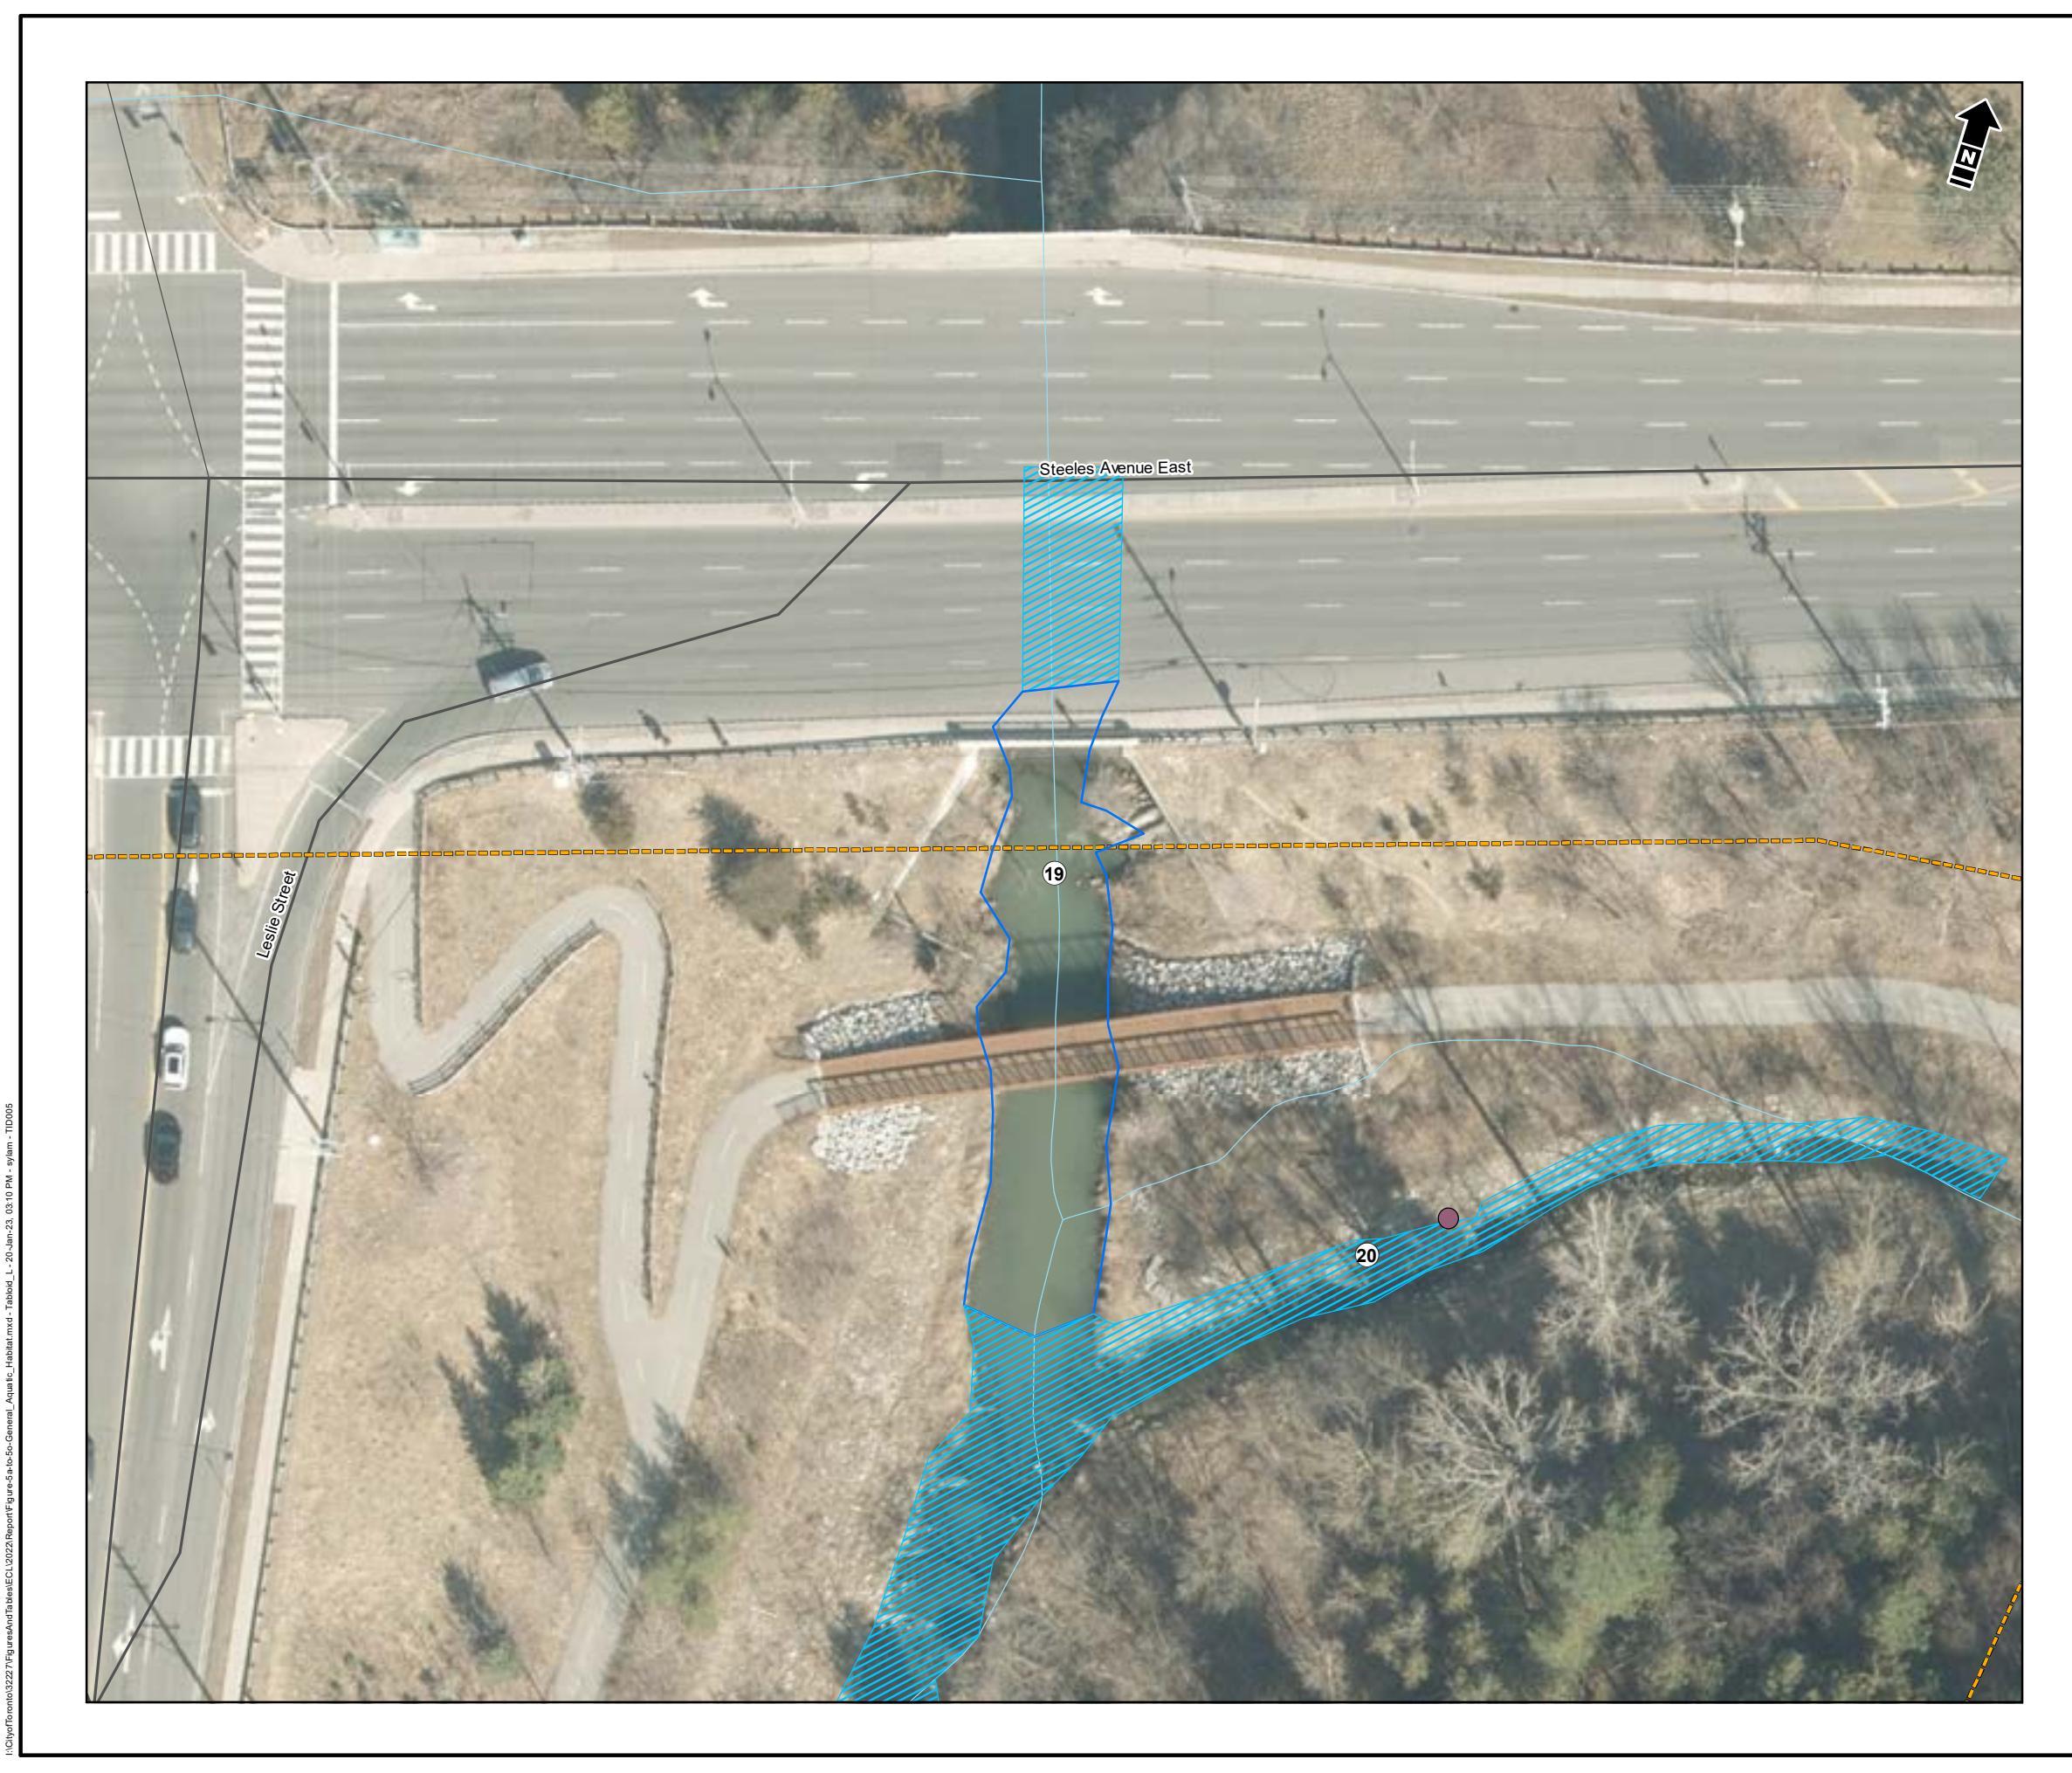
Notes: 19. Pool with a wetted width of 10.20 m and wetted depth of 1m. Both banks vegetated with tall grasses and shrubs. Sandy substrate. 20. Riffle with a wetted width of 2.3m and wetted depth of 19cm. Armourstone on right and left bank. Boulder and cobble substrate.

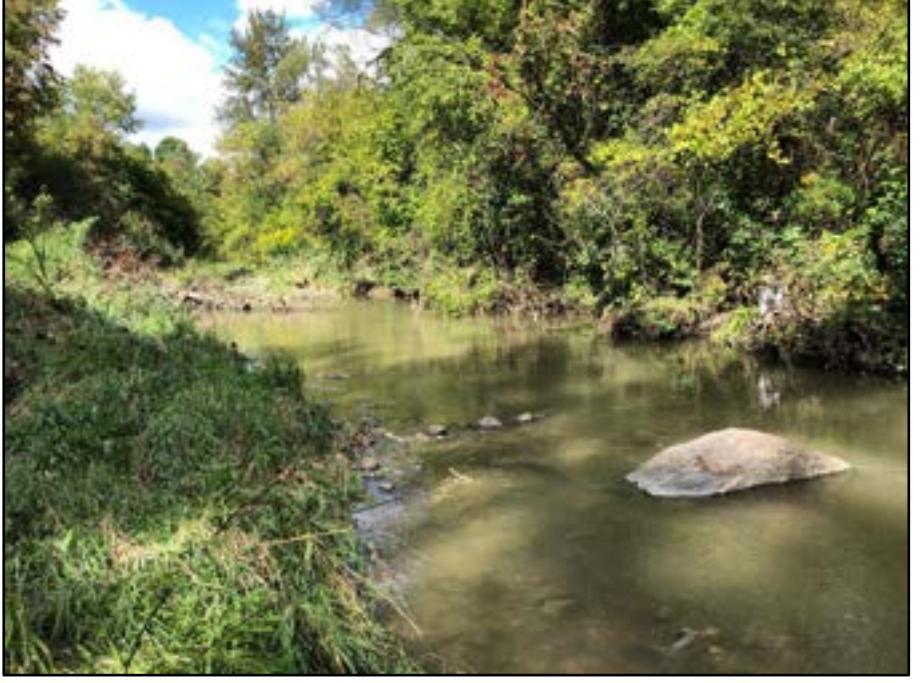
Photo 1 – YEAR 1 - German Mills Creek upstream of armourstone wall, looking upstream.

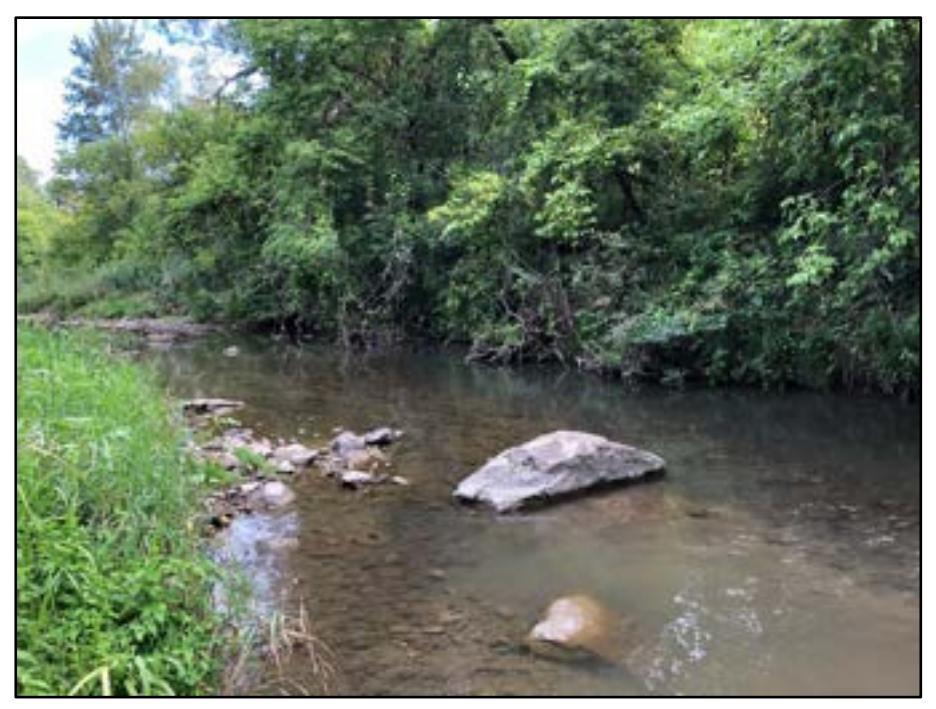
Photo 1 – YEAR 2 - German Mills Creek upstream of armourstone wall, looking upstream.

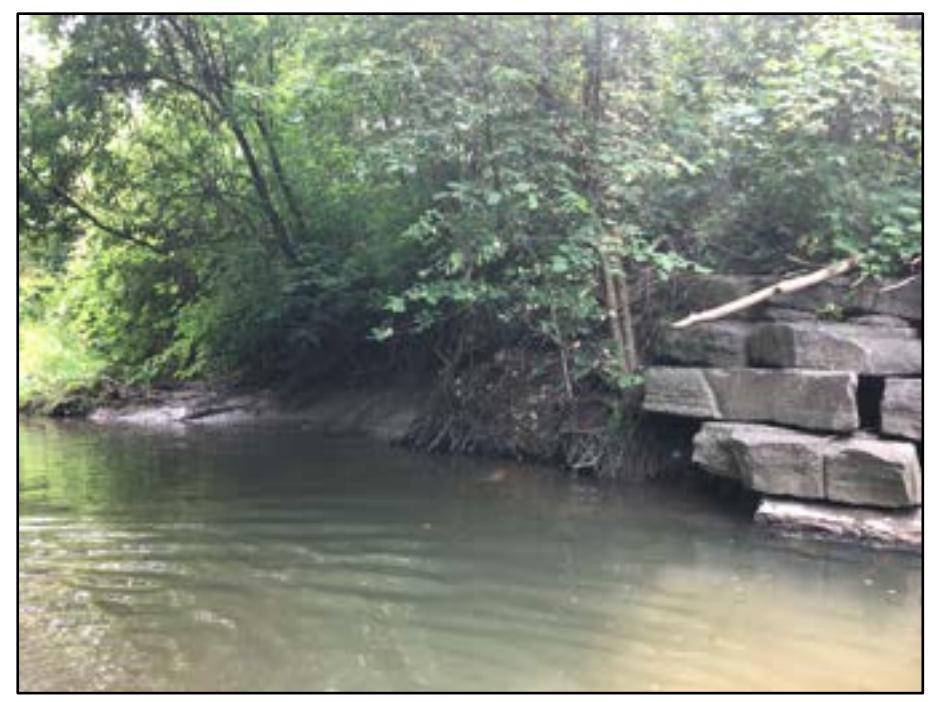
Photo 3 – YEAR 1 - South creek bank at downstream limit of armourstone wall.

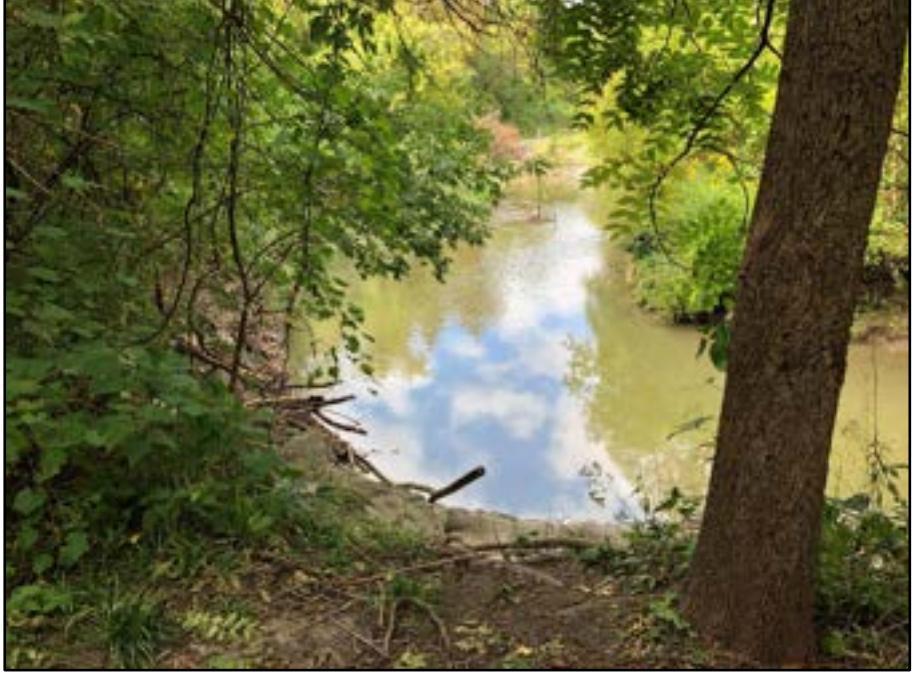
Photo 4 – YEAR 1 – View of creek looking upstream from top of armourstone wall.

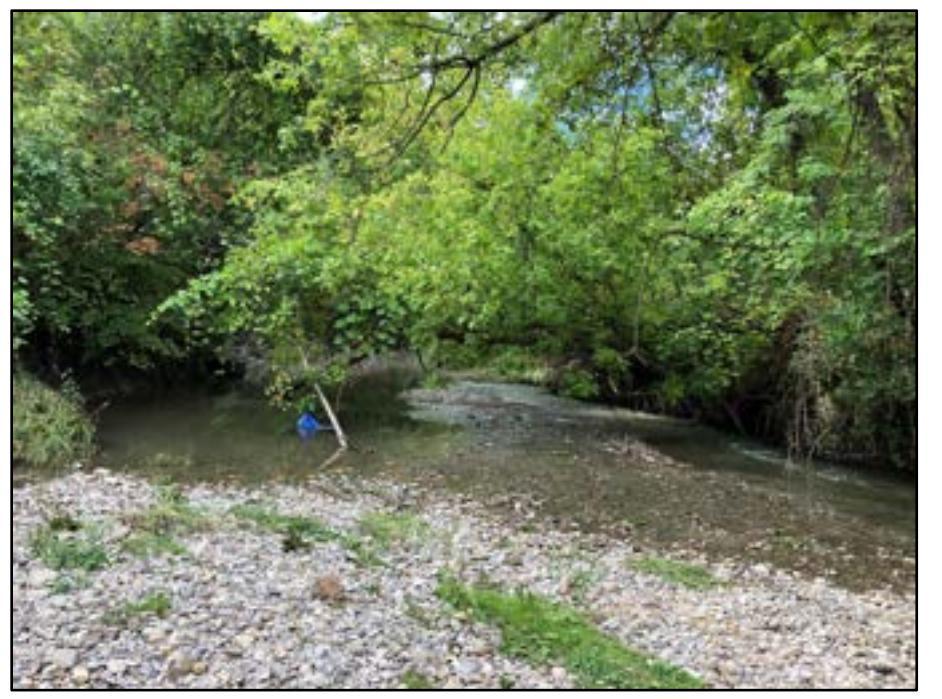
Photo 5 – YEAR 1 – View looking upstream near MON1-1.

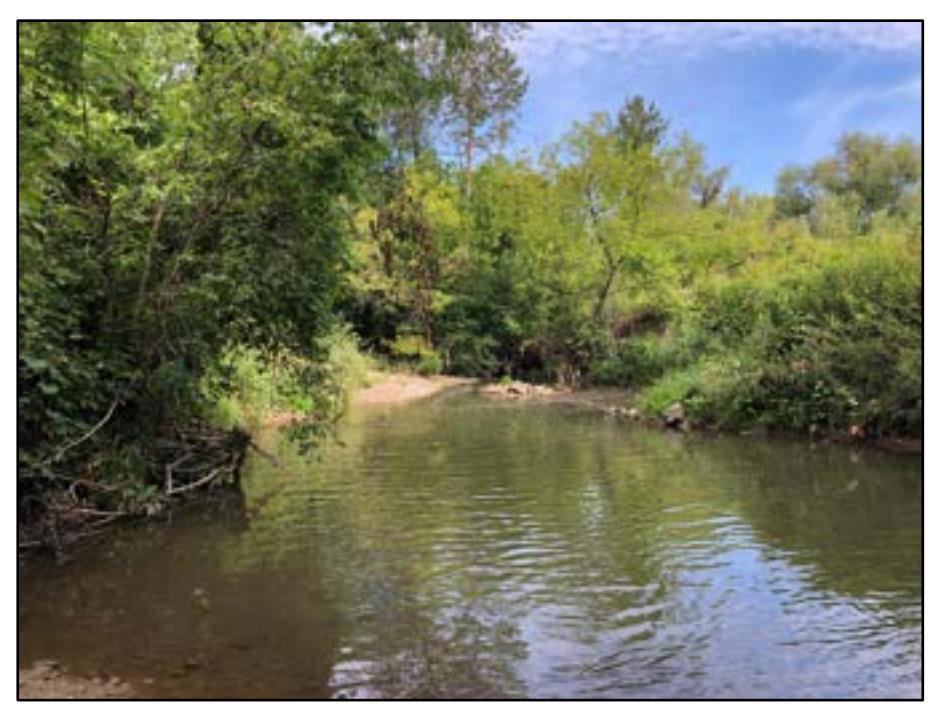
Photo 7 – YEAR 2 - View of pool with exposed manhole and riffle in background, looking upstream.

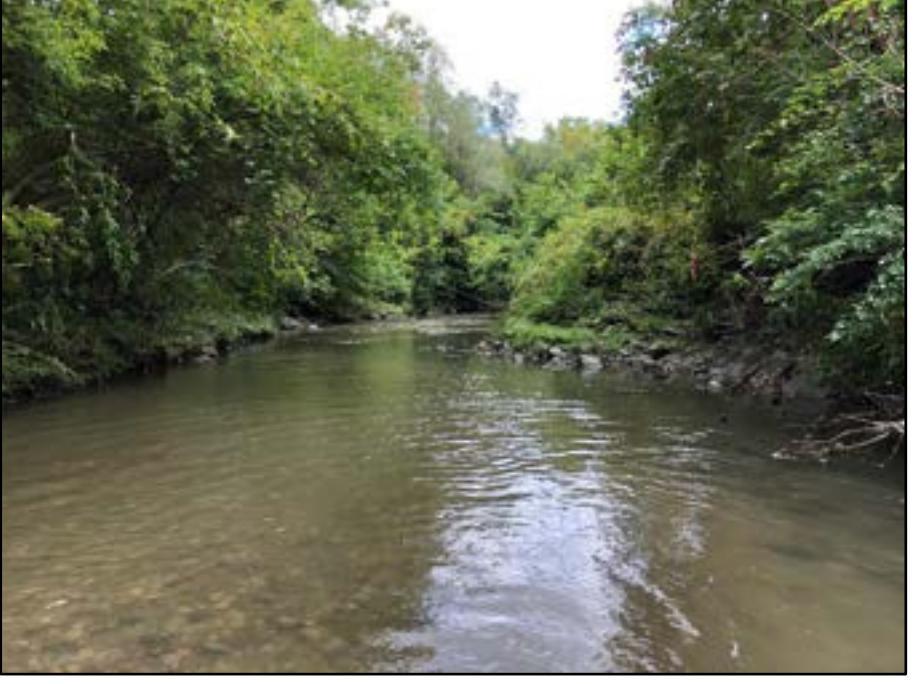
Photo 8 – YEAR 1 – View looking downstream near MON1-6.

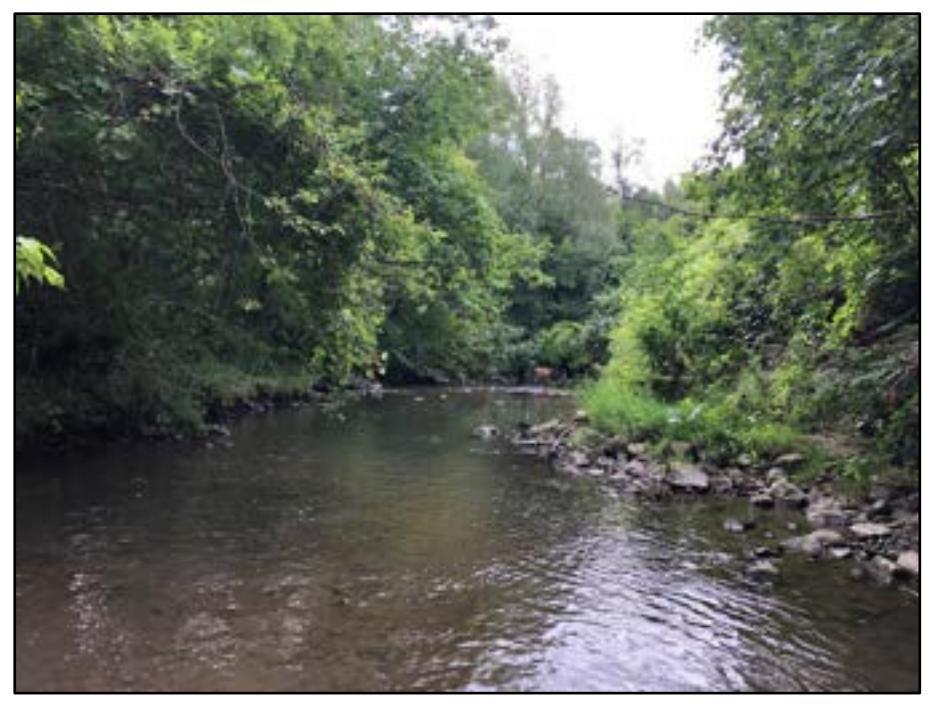
Photo 8 – YEAR 2 – View looking downstream near MON1-6.

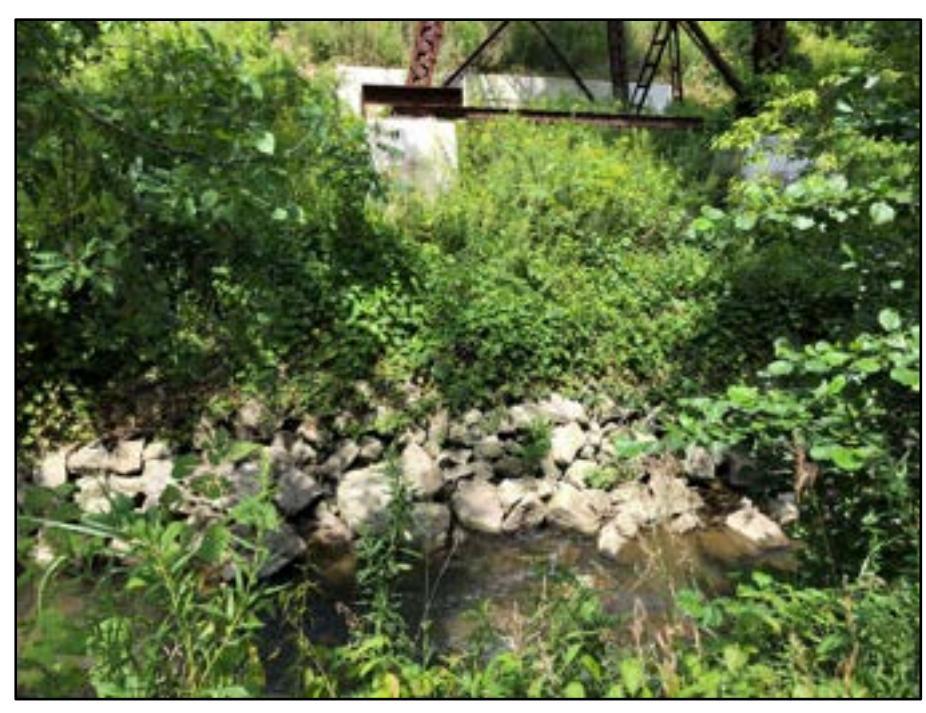
Photo 1 – YEAR 2 - Riffle below train bridge looking downstream.

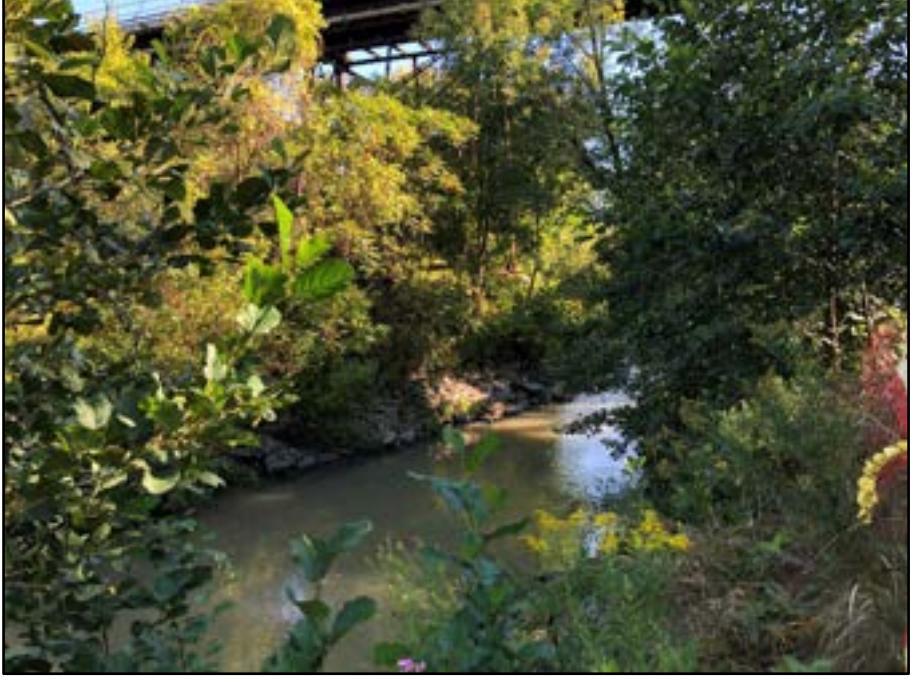
Photo 2 – YEAR 1 - MON2-1 area, view upstream toward train bridge.

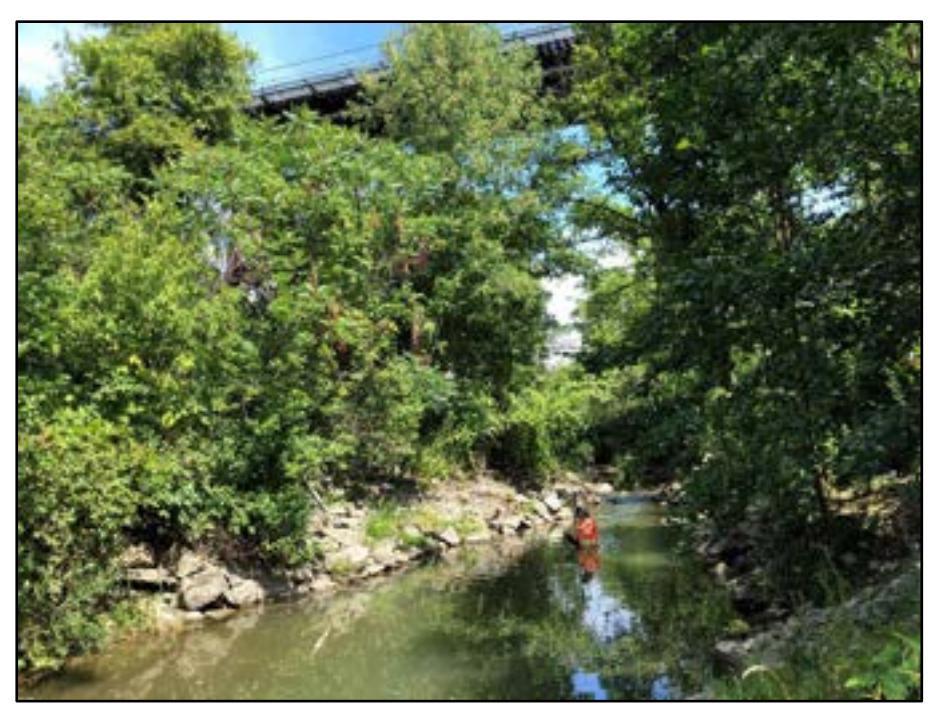
Photo 2 – YEAR 2 - MON2-1 area, view upstream toward train bridge.
