GERMAN MILLS CREEK GEOMORPHIC SYSTEMS MASTER PLAN MONITORING REPORT APPENDIX E

GERMAN MILLS CREEK GEOMORPHIC SYSTEMS MASTER PLAN SHORT-TERM EROSION MONITORING REPORT

GERMAN MILLS CREEK GEOMORPHIC SYSTEMS MASTER PLAN

SHORT TERM EROSION MONITORING REPORT

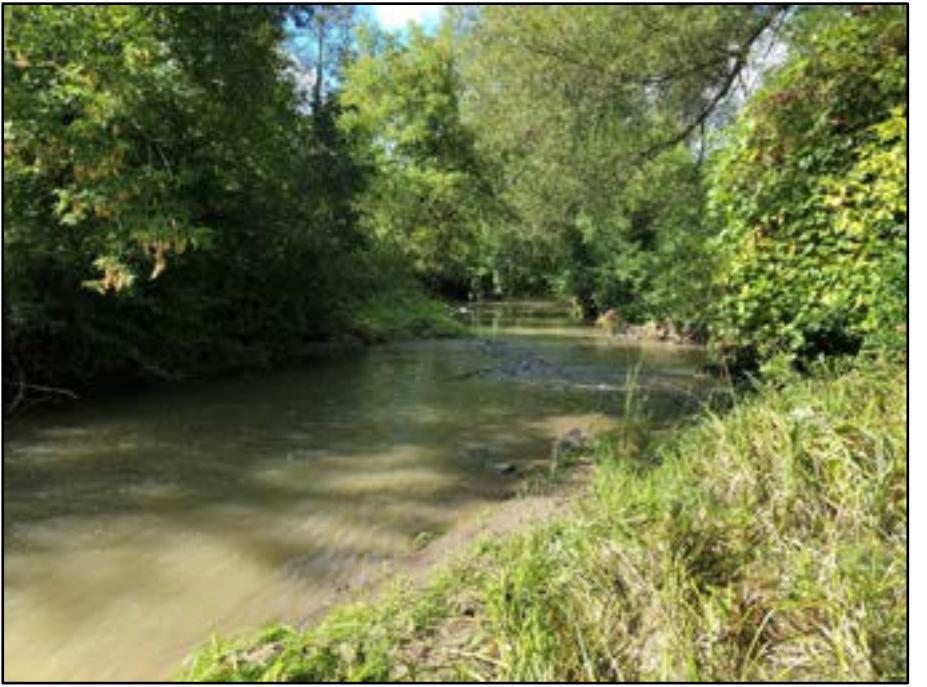
Photo 3 – YEAR 1 - View downstream from point bar on right bank just downstream of MON2-3

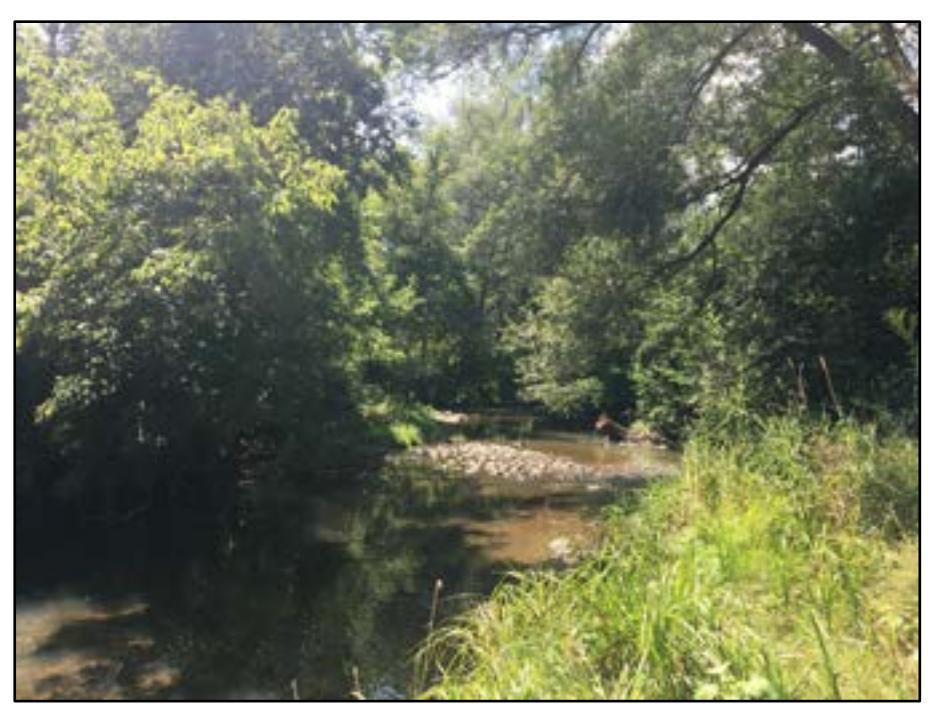
Photo 3 – YEAR 2 - View downstream from point bar on right bank just downstream of MON2-3

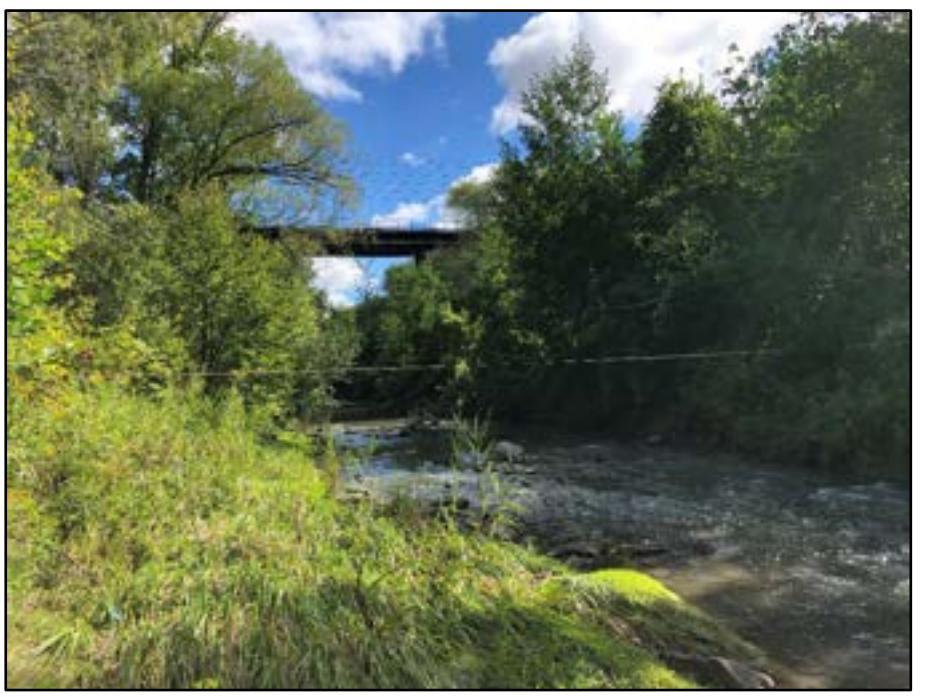
Photo 4 – YEAR 1 - View upstream from point bar on right bank just downstream of MON2-3

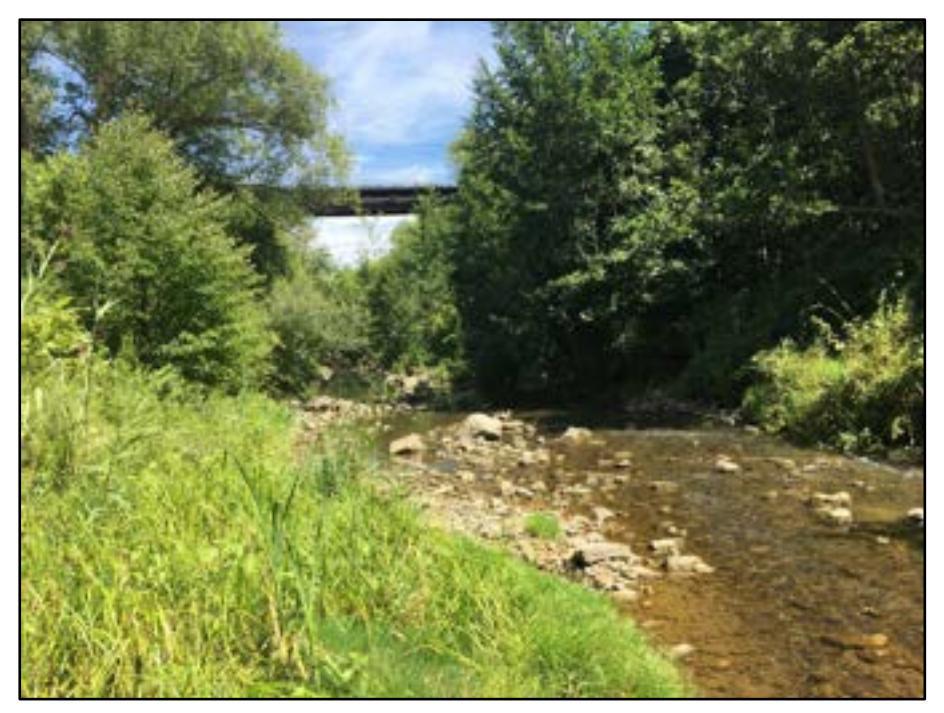
Photo 4 – YEAR 2 - View upstream from point bar on right bank just downstream of MON2-3

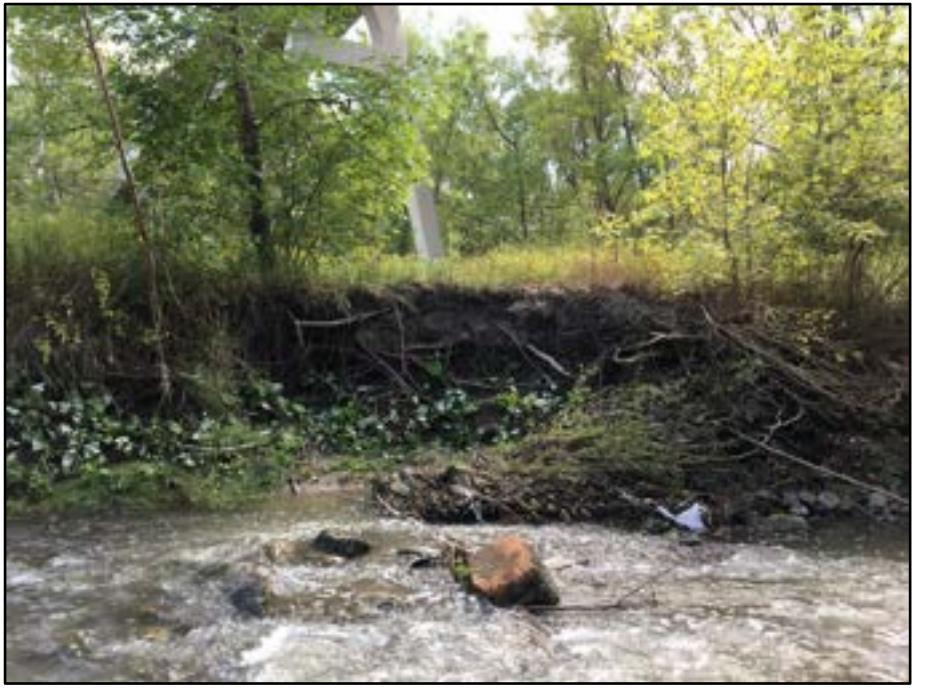
Photo 7 – YEAR 1 – South bank below pedestrian bridge

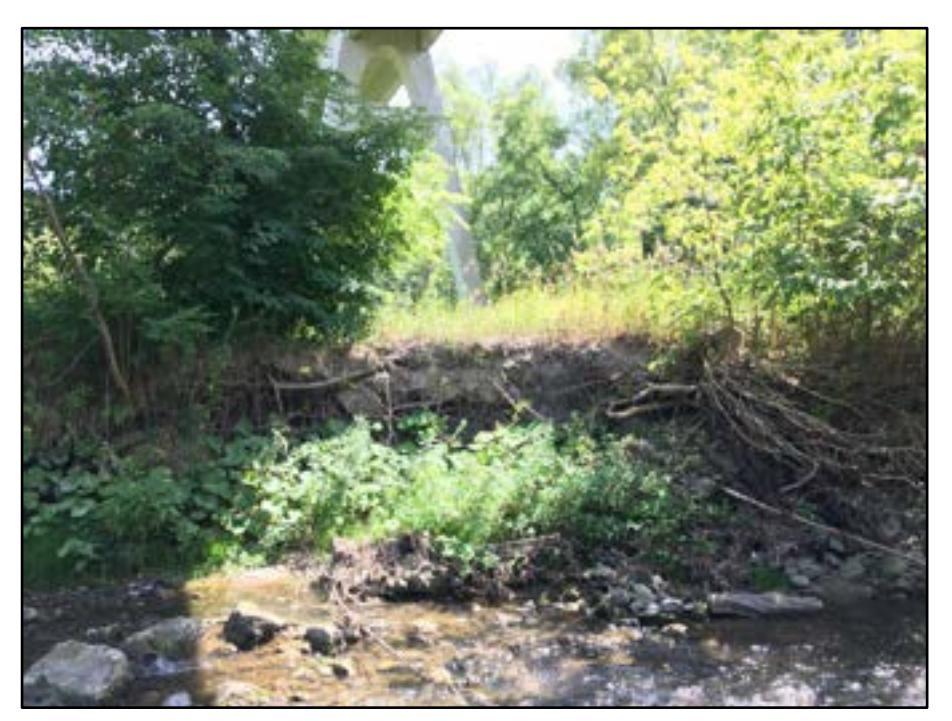
Photo 7 – YEAR 2 - South bank below pedestrian bridge. Additional vegetation covers the slumped material at toe.

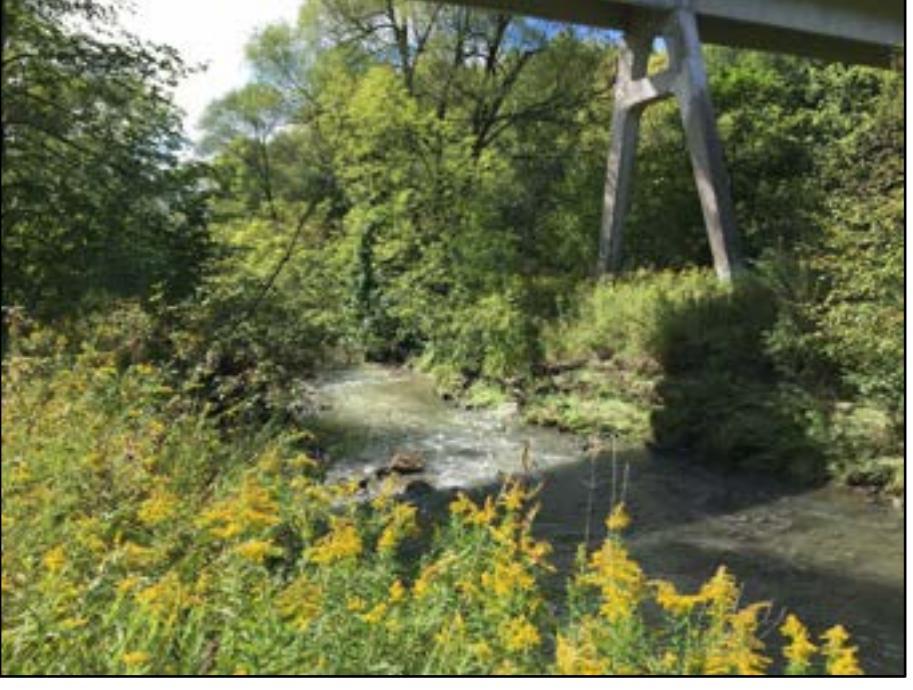
Photo 8 – YEAR 1 – View downstream below pedestrian bridge

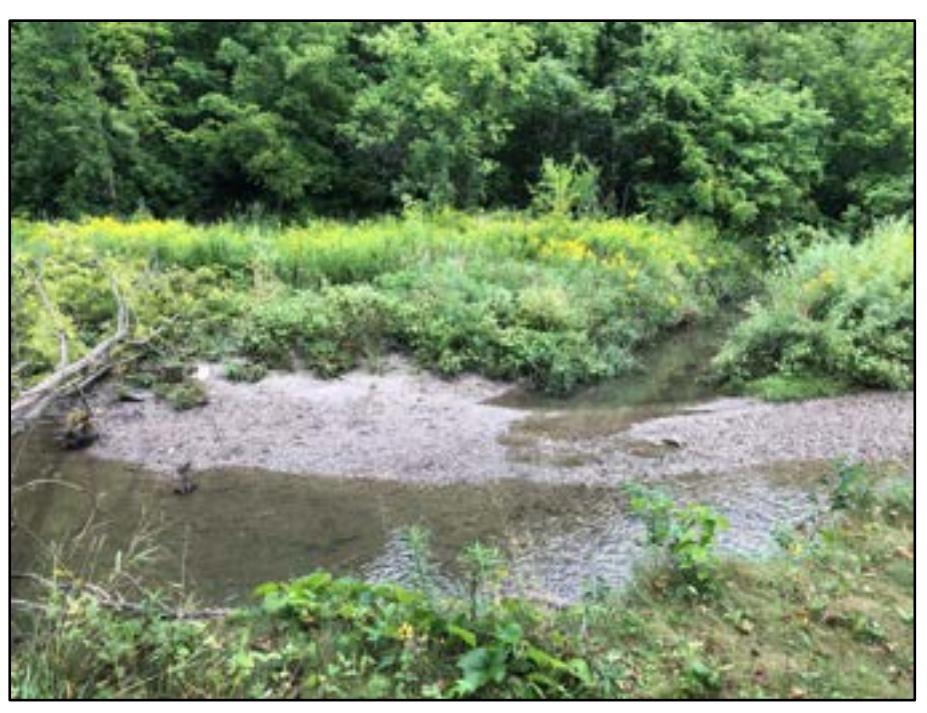
1. Bestview Tributary confluence with German Mills Creek. Additional sedimentation at confluence.

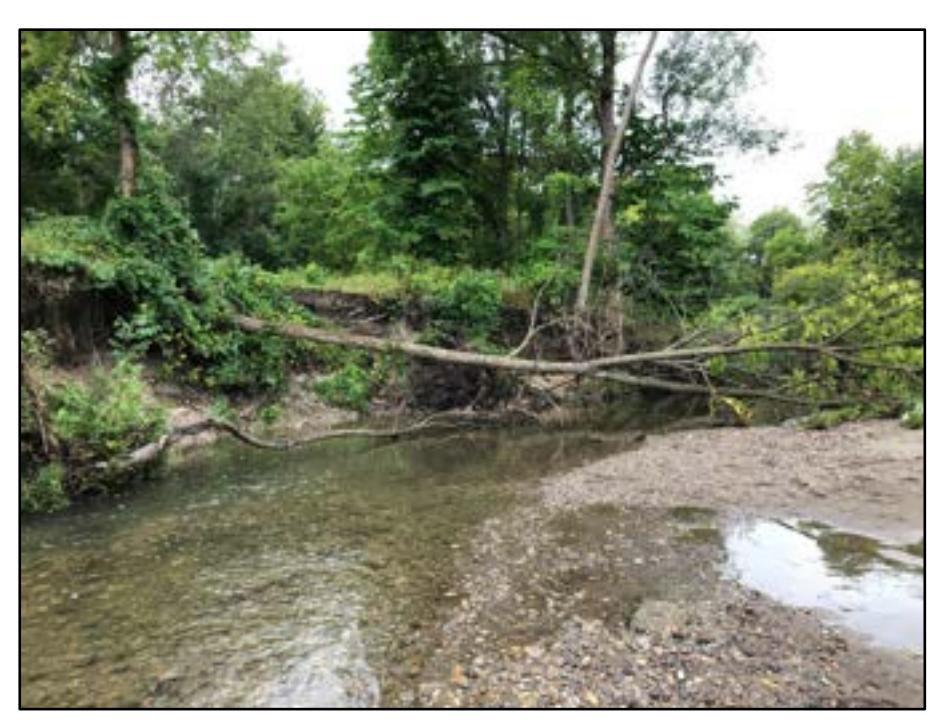
2. View downstream from north bank toward MON3-1. A different tree has fallen (leaves were still green on August 15, 2022) since the 2021 photograph, and the earlier tree has been pushed downstream. The top of bank appears to have receded.

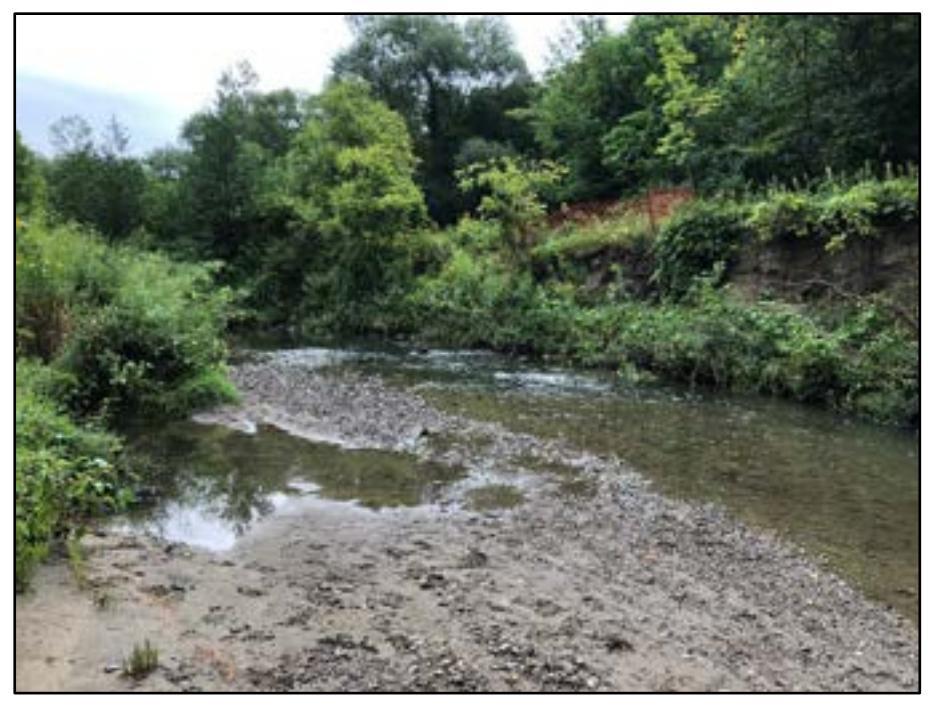
3. View upstream from south bank point bar at MON3-1. Minor slumping has occurred since 2021.

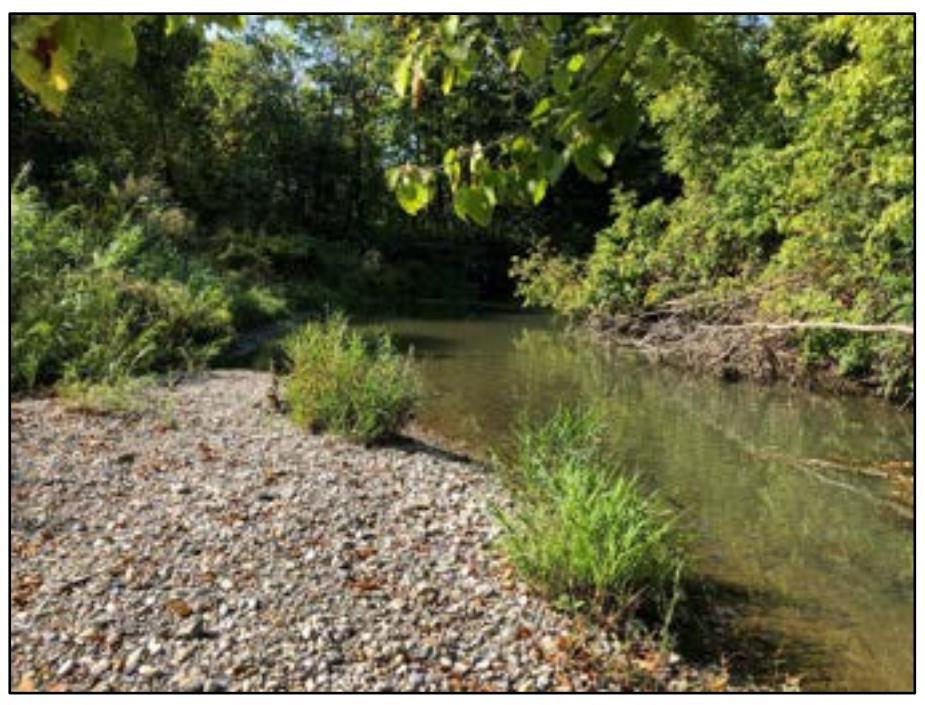
4. View downstream from south bank point bar at MON3-3. Bar appears to be similar.

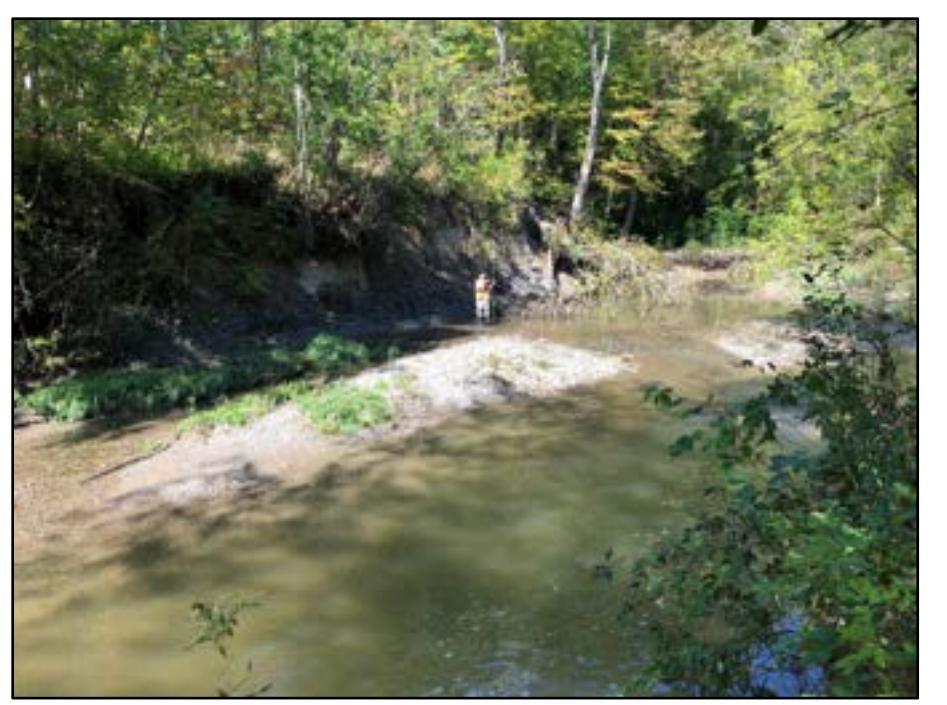
6. View downstream at MON3-5 from south bank. Vegetation has filled in on upper part of bank while the lower part of the bar remains unvegetated and covered in fresh deposits of fines.

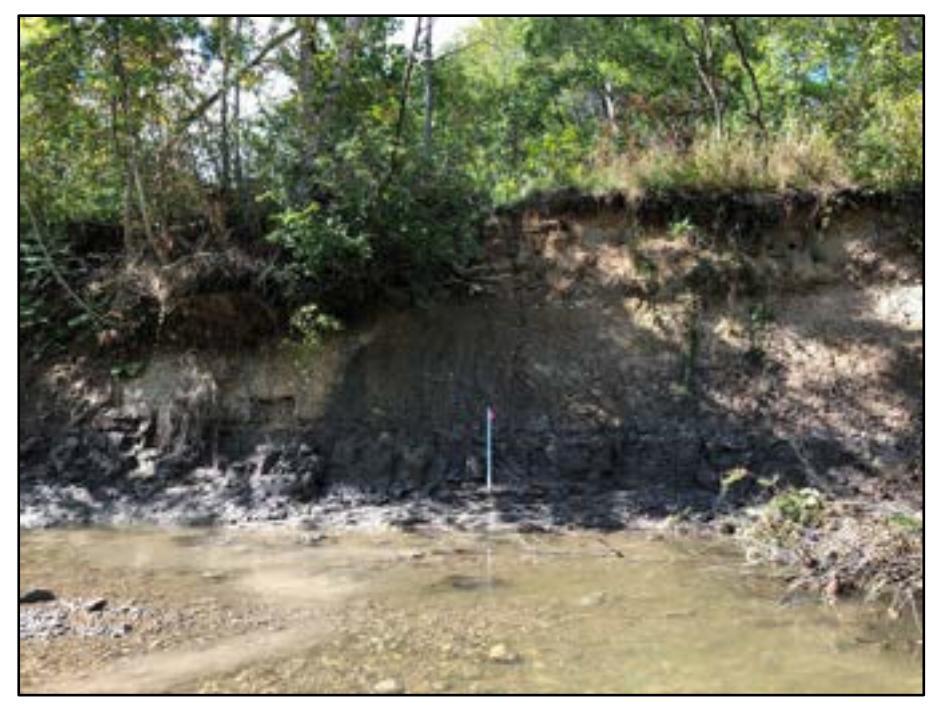
7. View upstream toward MON3-6 from south bank. Top of bank has receded slightly. Bar material has migrated downstream. Large woody debris has accumulated upstream of exposed bank at a meander.
